# **FEDERAL TRANSIT BUS TEST**

**Manufacturer: High Level Enterprises, Inc.  
Model: 16 + 2WC**

**November 2024**

**Report Number: LTI-BT-R2024-04**

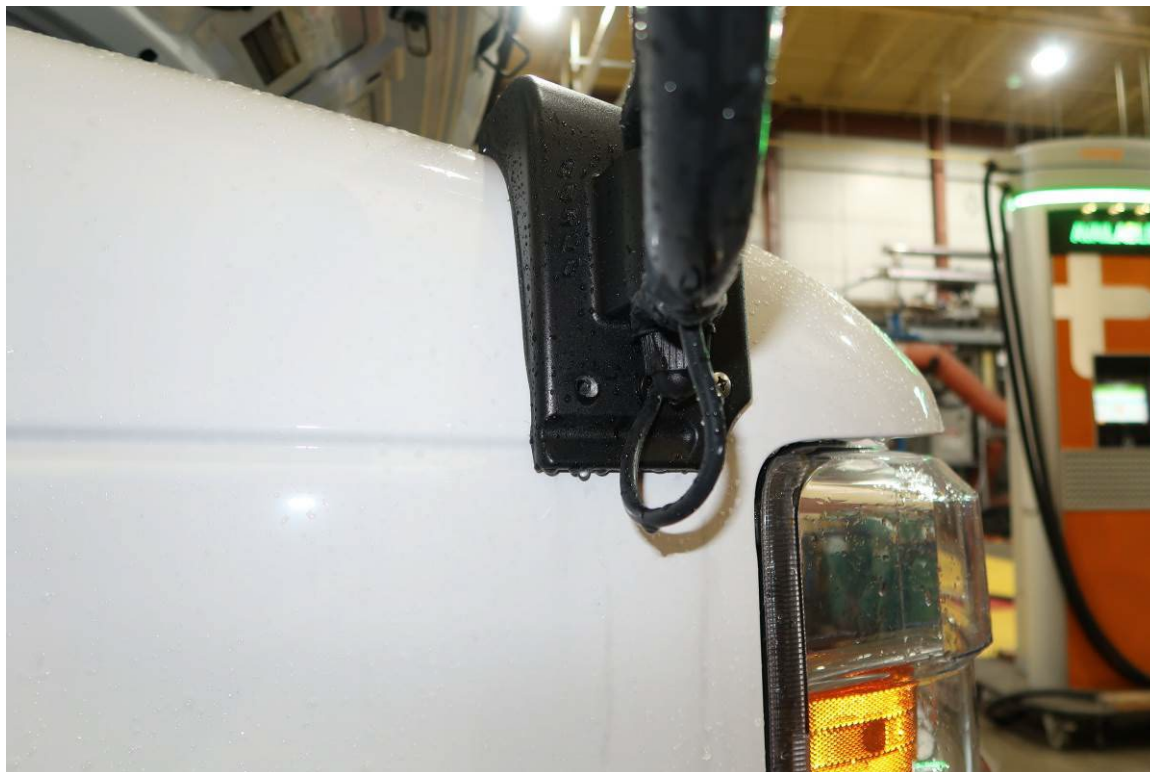
**SCREW FELL OUT OF CURBSIDE MIRROR  
(300 TEST MILES)**

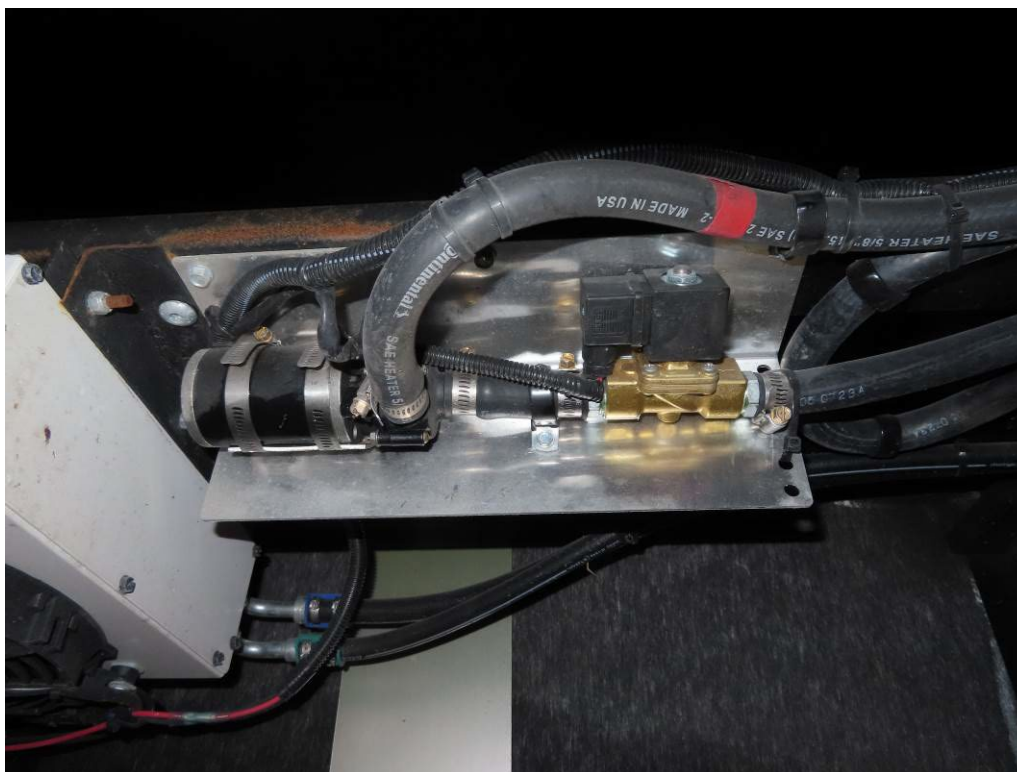
**COOLANT PUMP ASSEMBLY REPLACED  
(1,123 TEST MILES)**

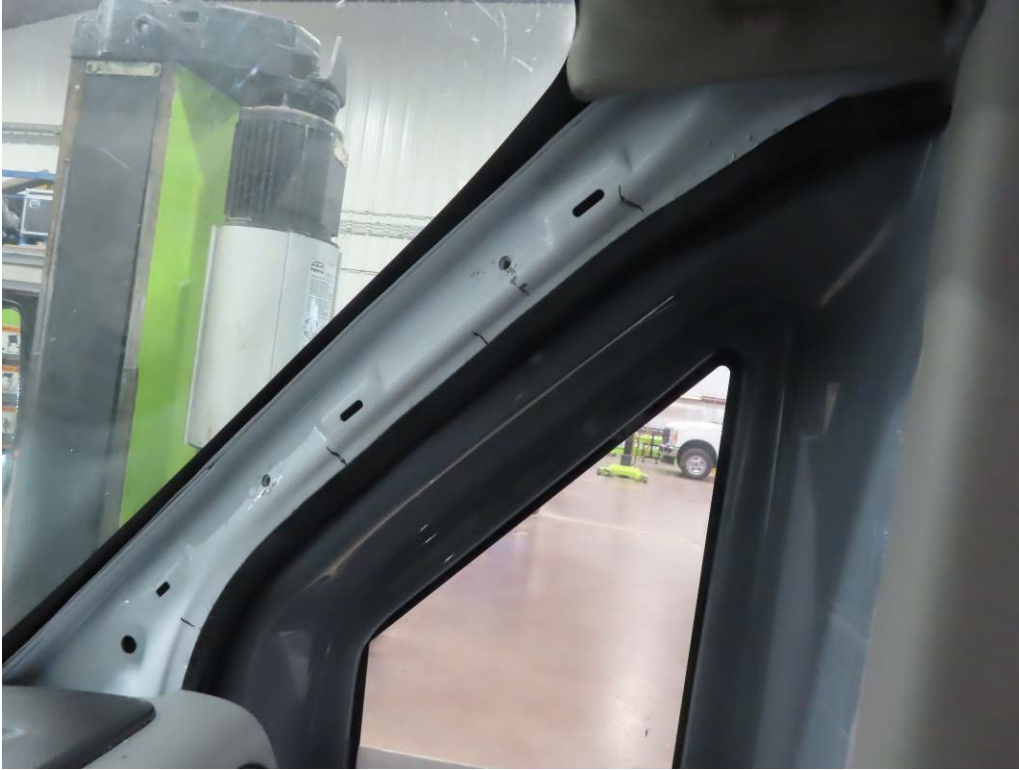
**SCREWS THAT HOLD THE OUTER PANEL ON THE SUPPORT POST  
ADJACENT TO THE WINDSHIELD ON THE CURBSIDE ARE BROKEN  
(1,123 TEST MILES)**

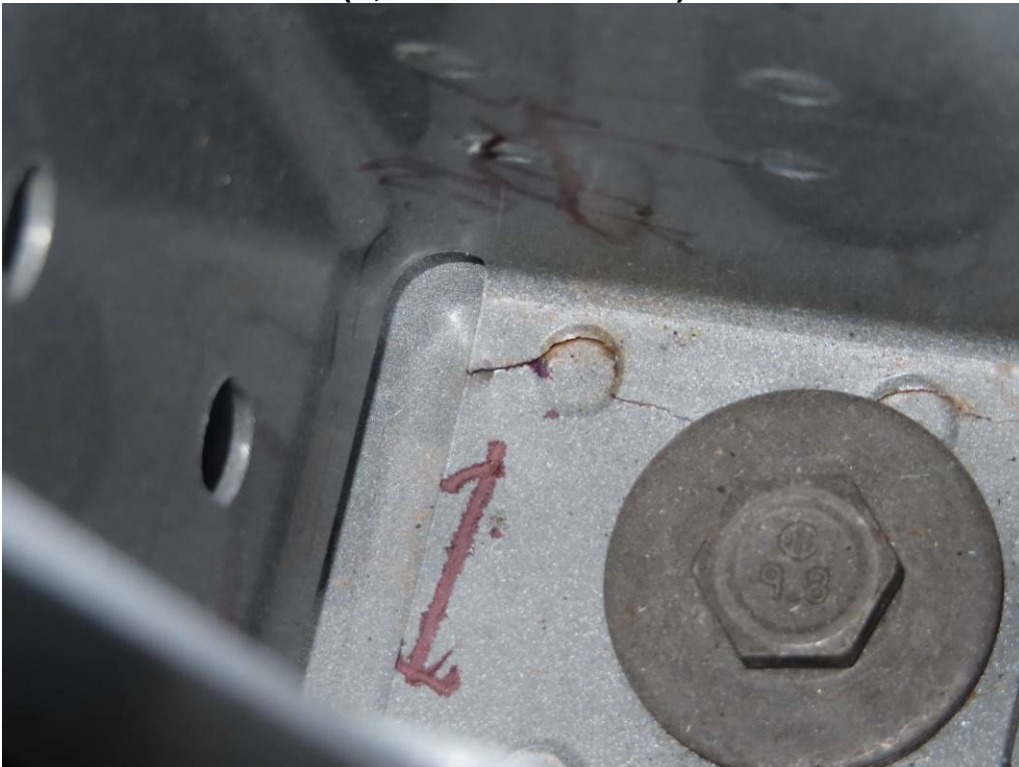
**CRACK #1 – SPOT WELDS AROUND CORE SUPPORT, STREETSIDE  
(1,123 TEST MILES)**

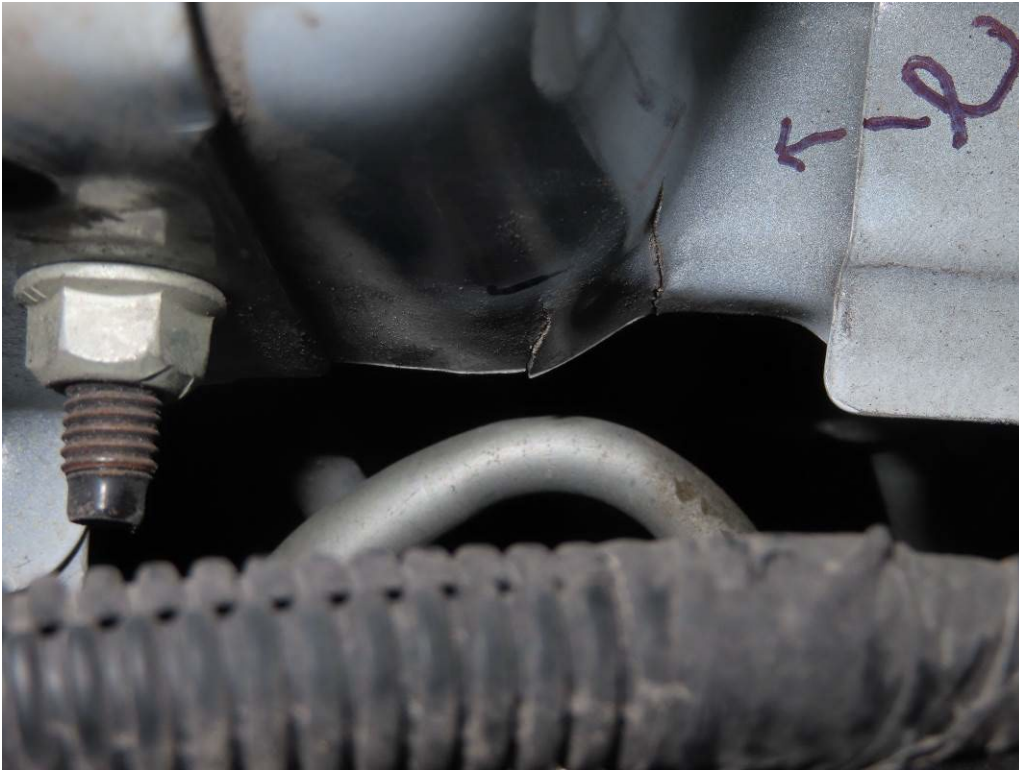
**CRACK #2 – CRACKS IN BODY ABOVE THE FRAME FORWARD OF THE  
SUSPENSION SPRING IN THE FRONT STREETSIDE WHEEL WELL  
(1,123 TEST MILES)**

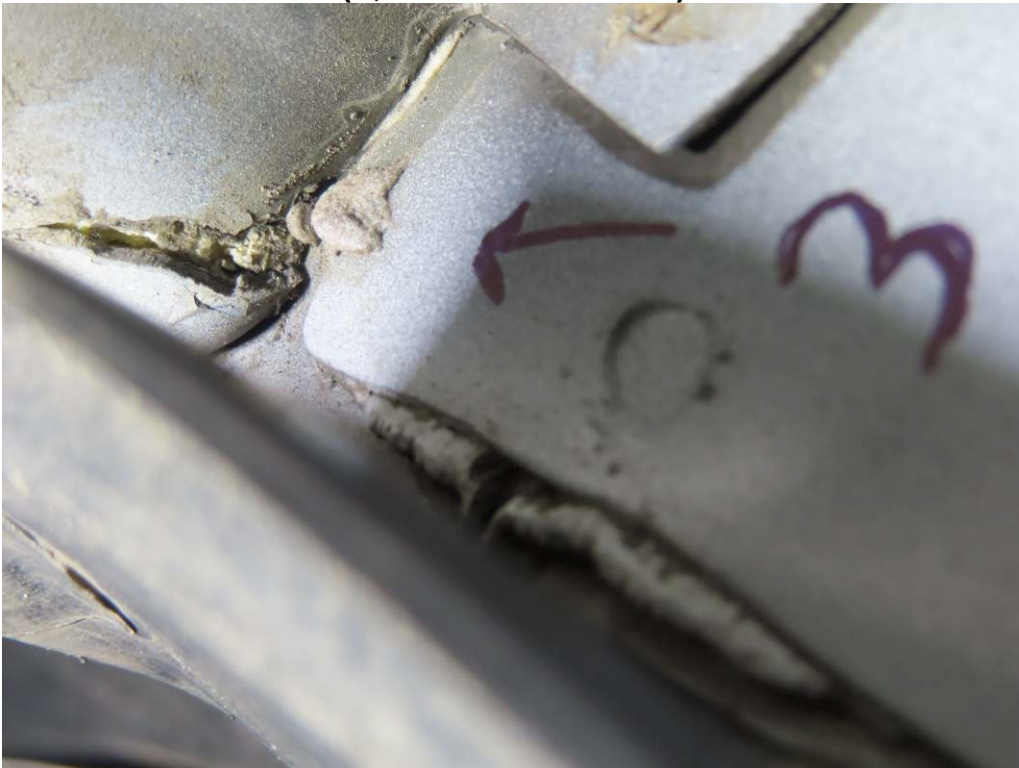
**CRACK #3 – FRONT CURBSIDE INNER FENDER IS PULLING  
AWAY/CRACKED ON THE REAR LOWER SIDE  
(1,123 TEST MILES)**

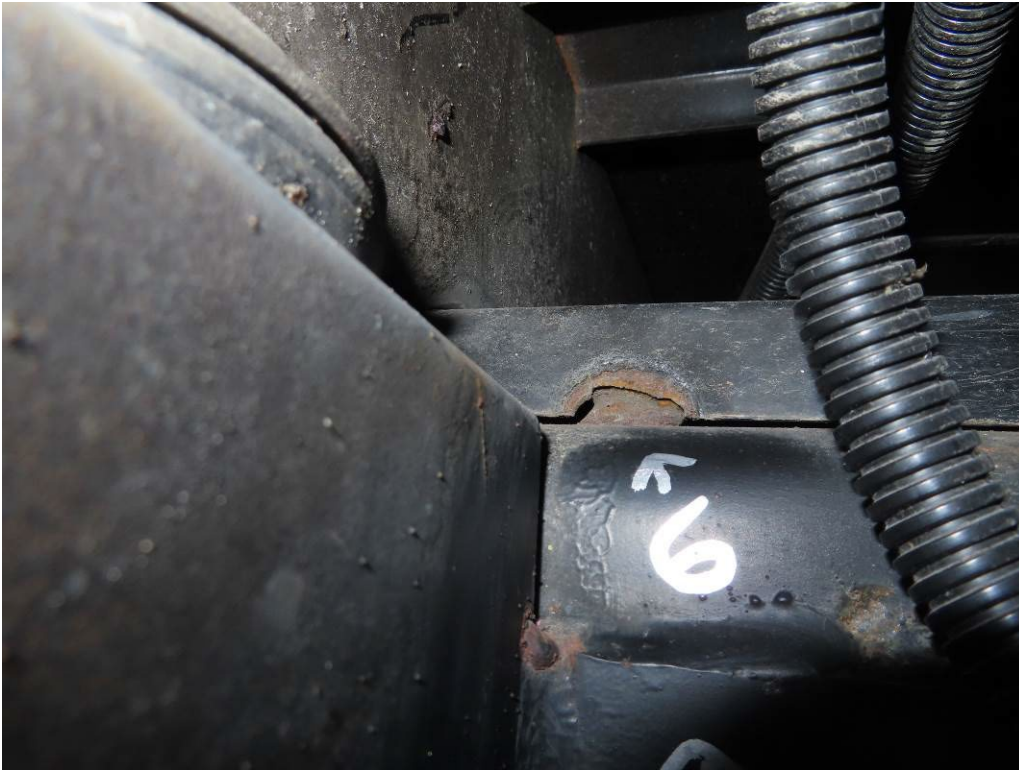
**CRACK #6 – TOP OF THE CURBSIDE FRAME  
WHERE THE HEATSHIELD IS WELDED  
(1,123 TEST MILES)**

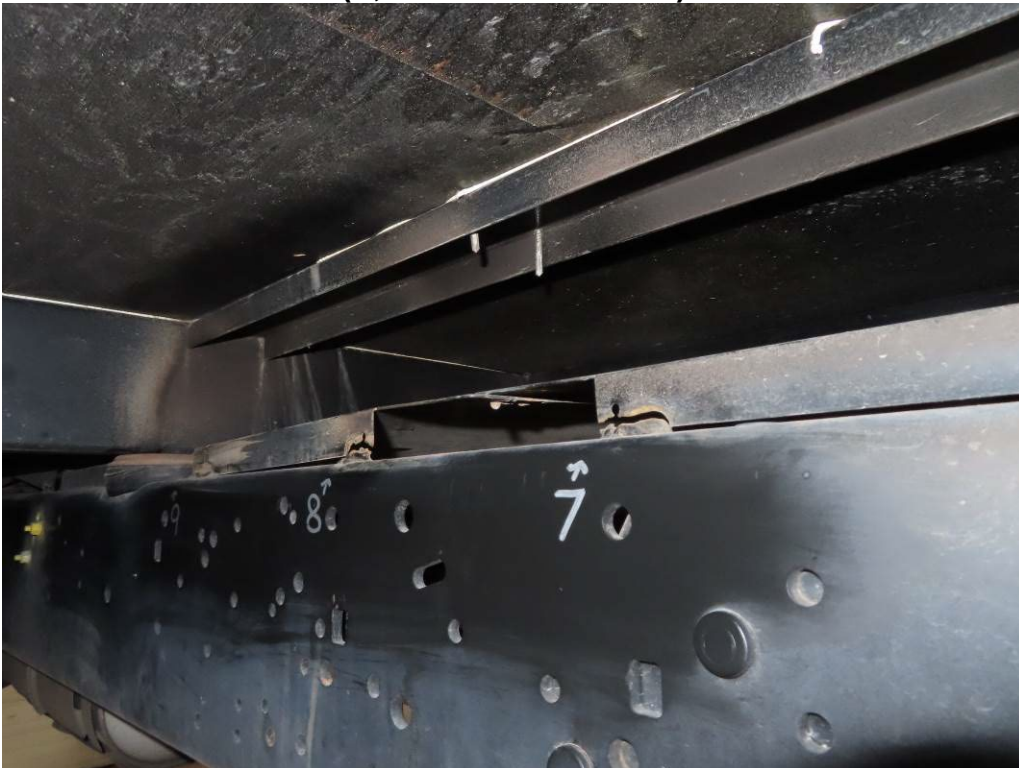
**CRACKS #7, 8 & 9 – TOP OF THE CURBSIDE FRAME  
WHERE THE HEATSHIELD IS WELDED  
(1,123 TEST MILES)**

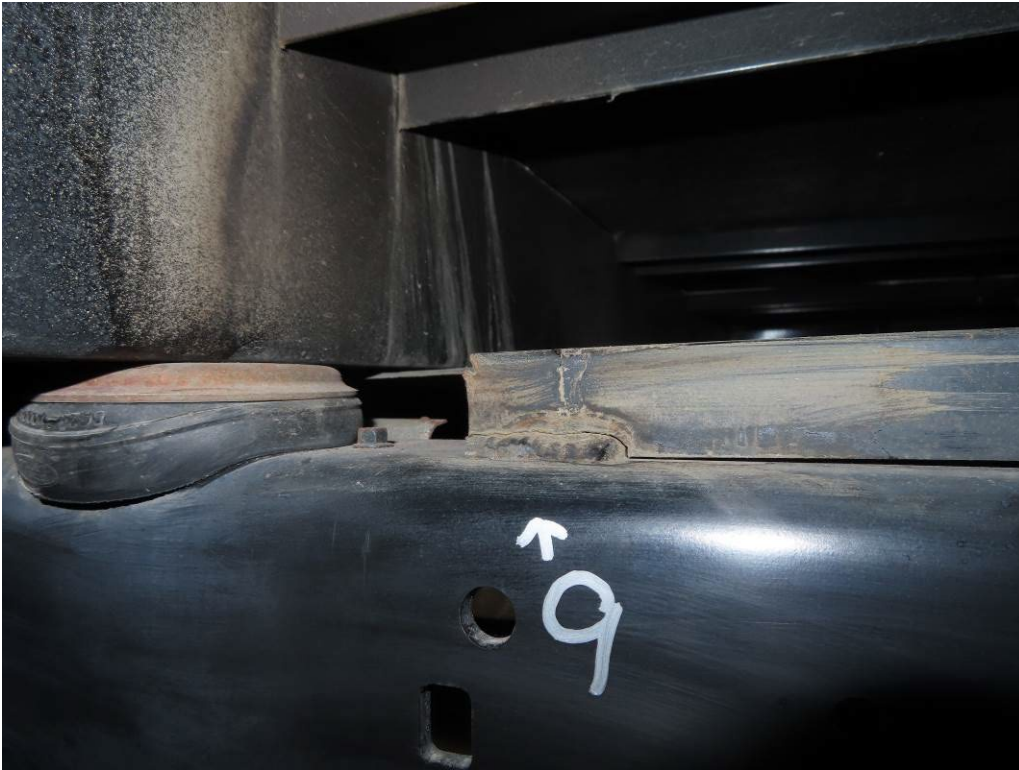
**CRACK #9 – TOP OF THE CURBSIDE FRAME  
WHERE THE HEATSHIELD IS WELDED  
(1,123 TEST MILES)**

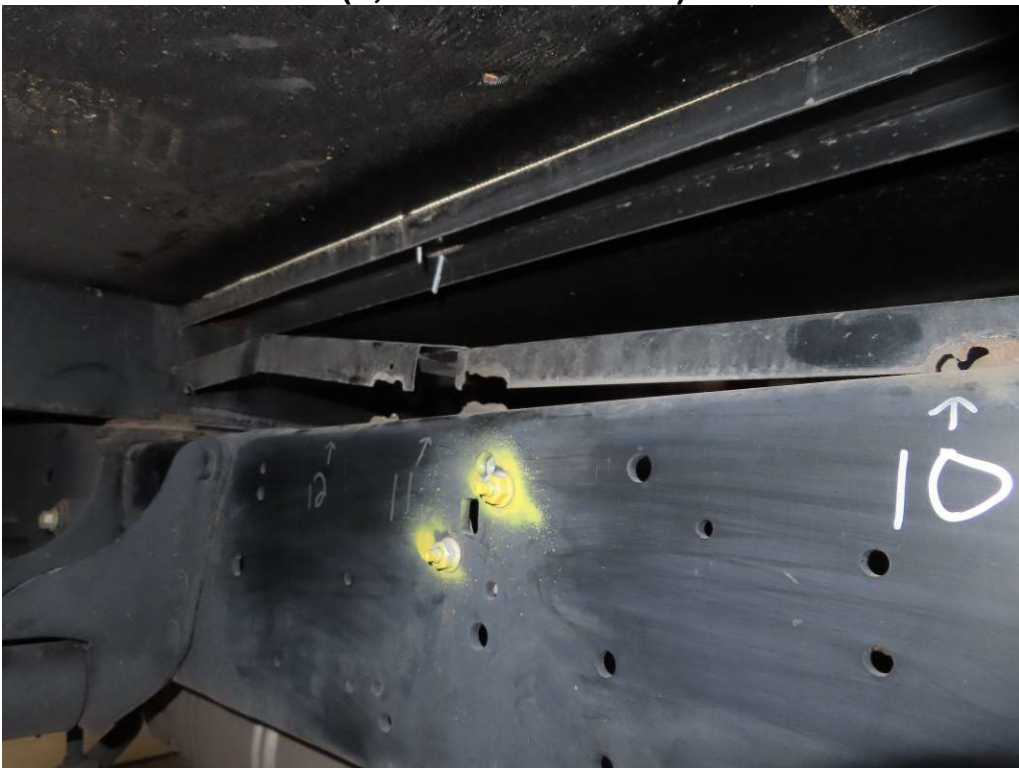
**CRACKS #10, 11 & 12 – TOP OF THE CURBSIDE FRAME  
WHERE THE HEATSHIELD IS WELDED  
(1,123 TEST MILES)**

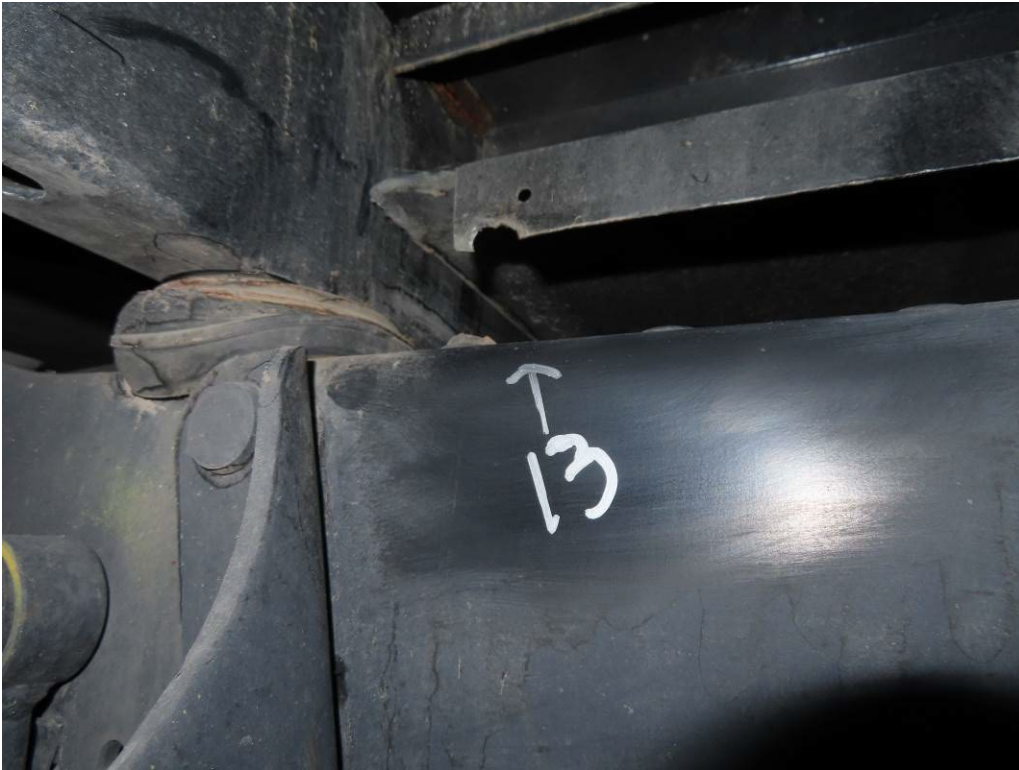
**CRACK #13 – TOP OF THE CURBSIDE FRAME  
WHERE THE HEATSHIELD IS WELDED  
(1,123 TEST MILES)**

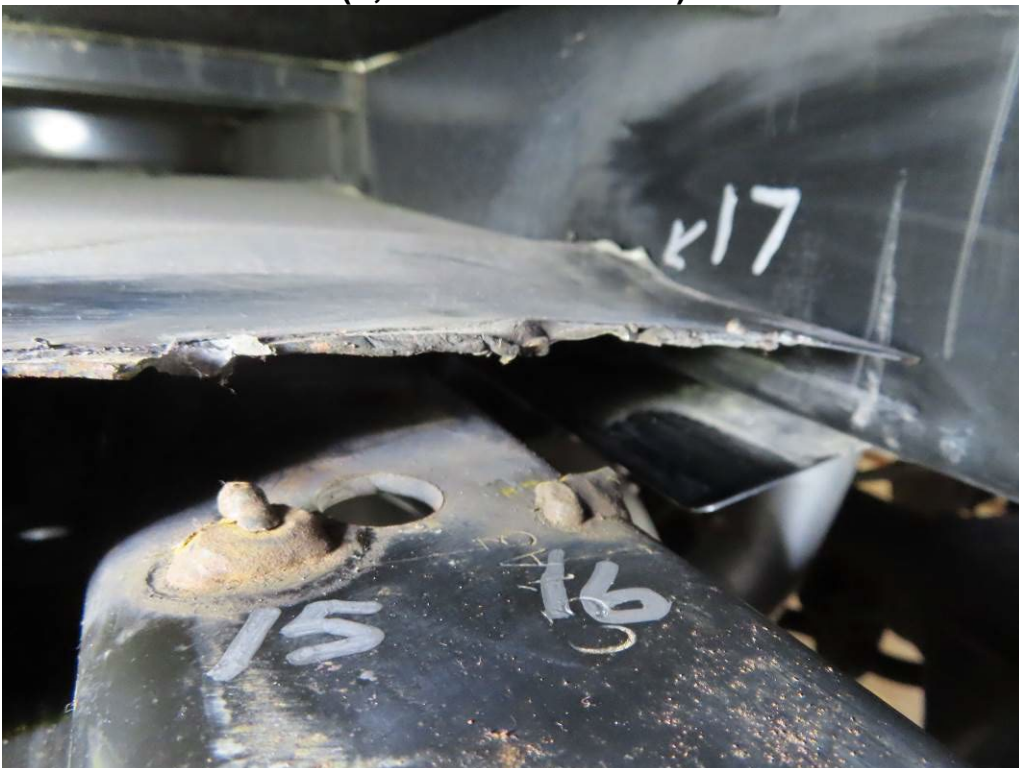
**CRACKS #15, 16 & 17 – ADDITIONAL CRACKS  
WHERE HEATSHIELD WELDED AT THE REAR  
(1,123 TEST MILES)**

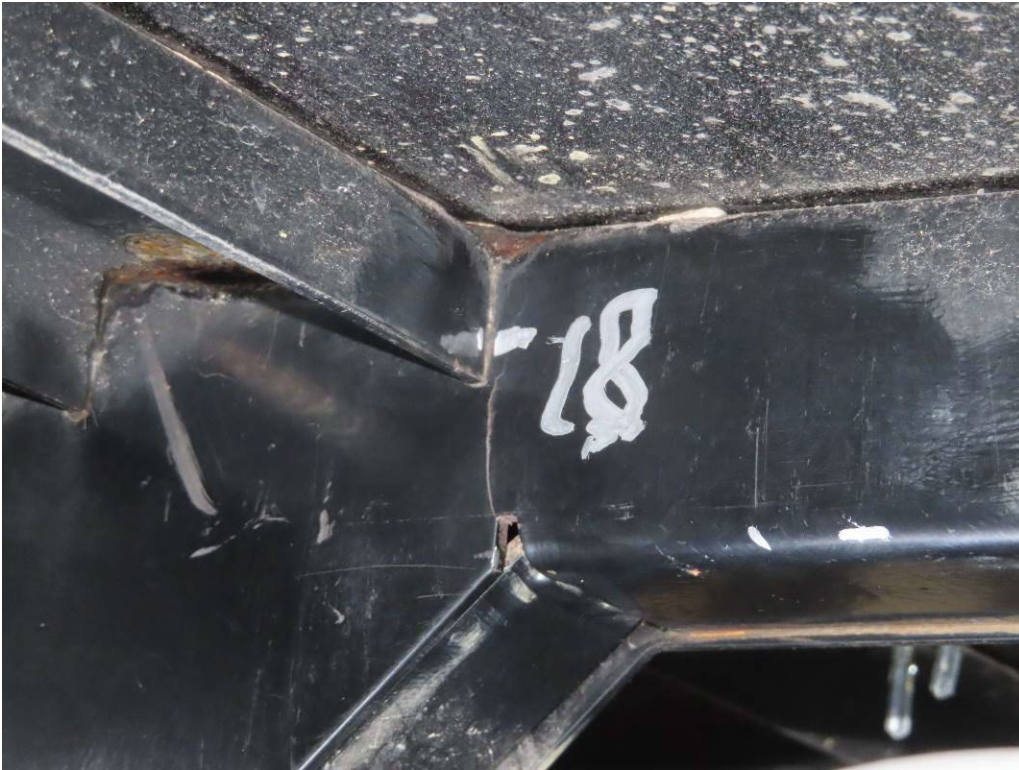
**CRACK #18 – CURBSIDE CROSSBEAM WHERE CUT OUTS  
WERE MADE FOR FUEL TANK  
(1,123 TEST MILES)**

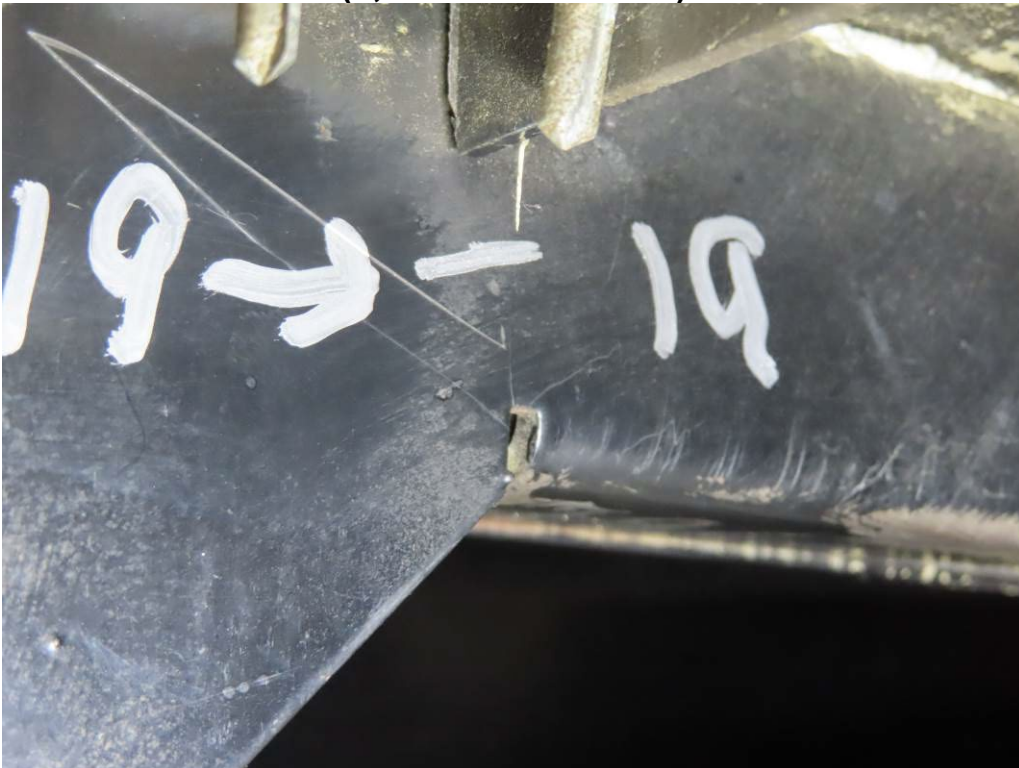
**CRACK #19 – CURBSIDE CROSSBEAM WHERE CUT OUTS  
WERE MADE FOR FUEL TANK  
(1,123 TEST MILES)**

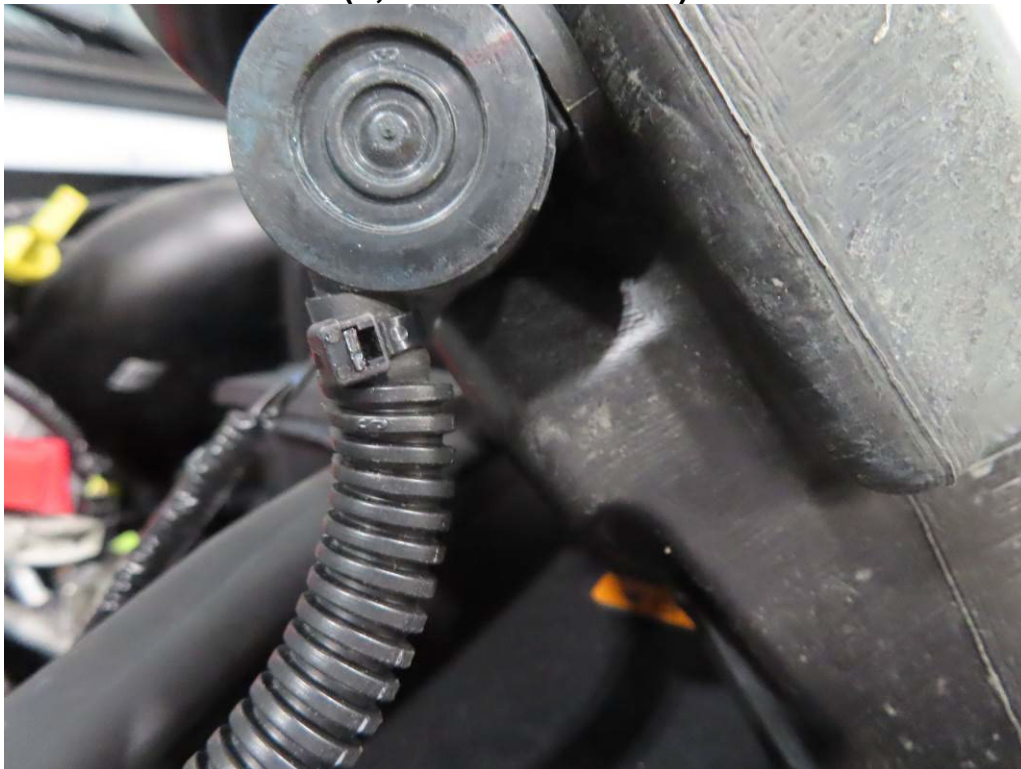
**REPAIRED BROKEN HOSE ON WASHER PUMP  
(2,521 TEST MILES)**

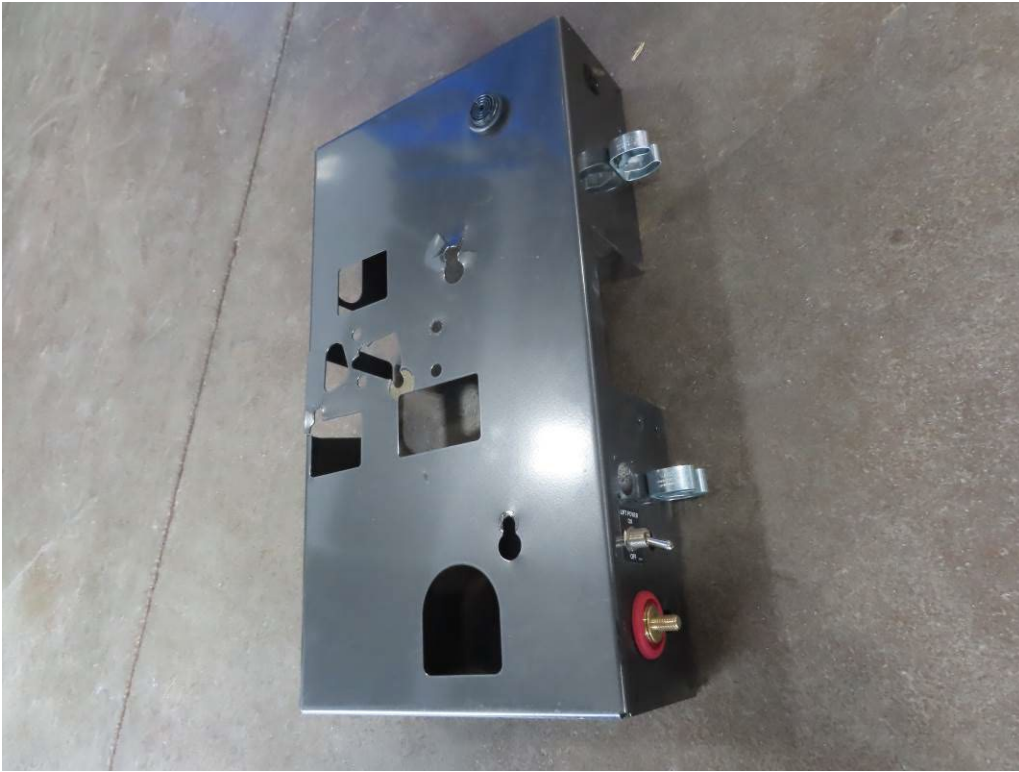
**BROKEN COVER PANEL OF POWER BOX FOR ADA LIFT  
(2,521 TEST MILES)**

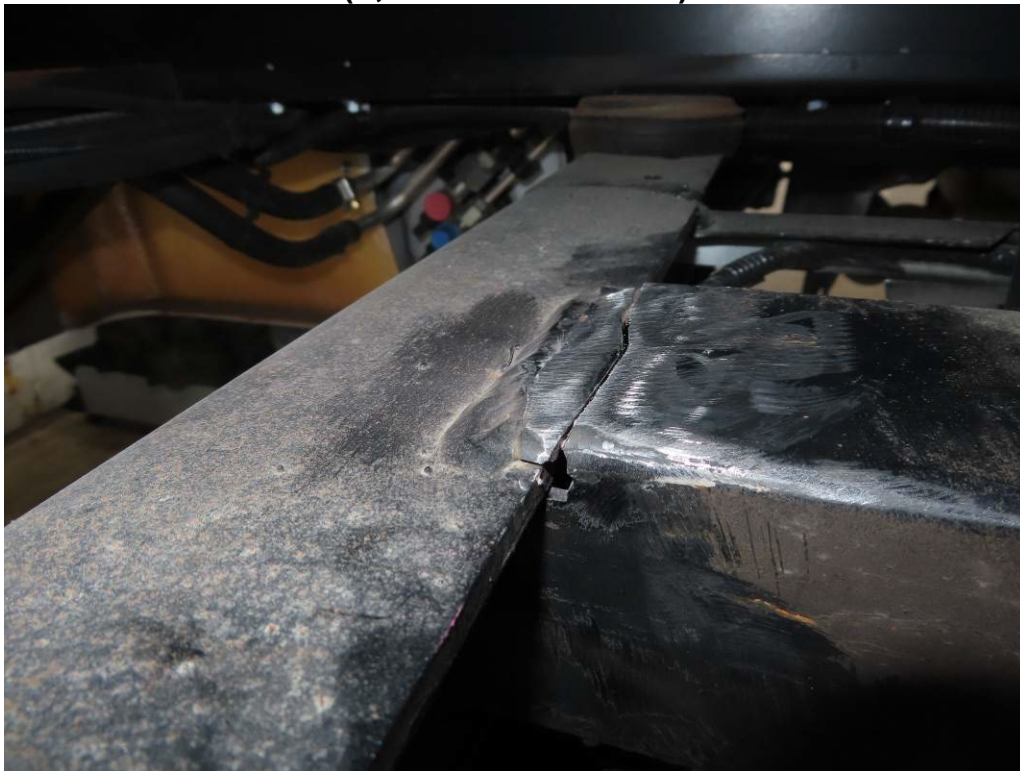
## CRACK #24 – CROSSBEAM TO WHICH FRONT CARRIER BEARING IS ATTACHED CRACKED ON STREETSIDE FRAME RAIL WHERE IT IS WELDED – PREPPED FOR WELDING (2,521 TEST MILES)

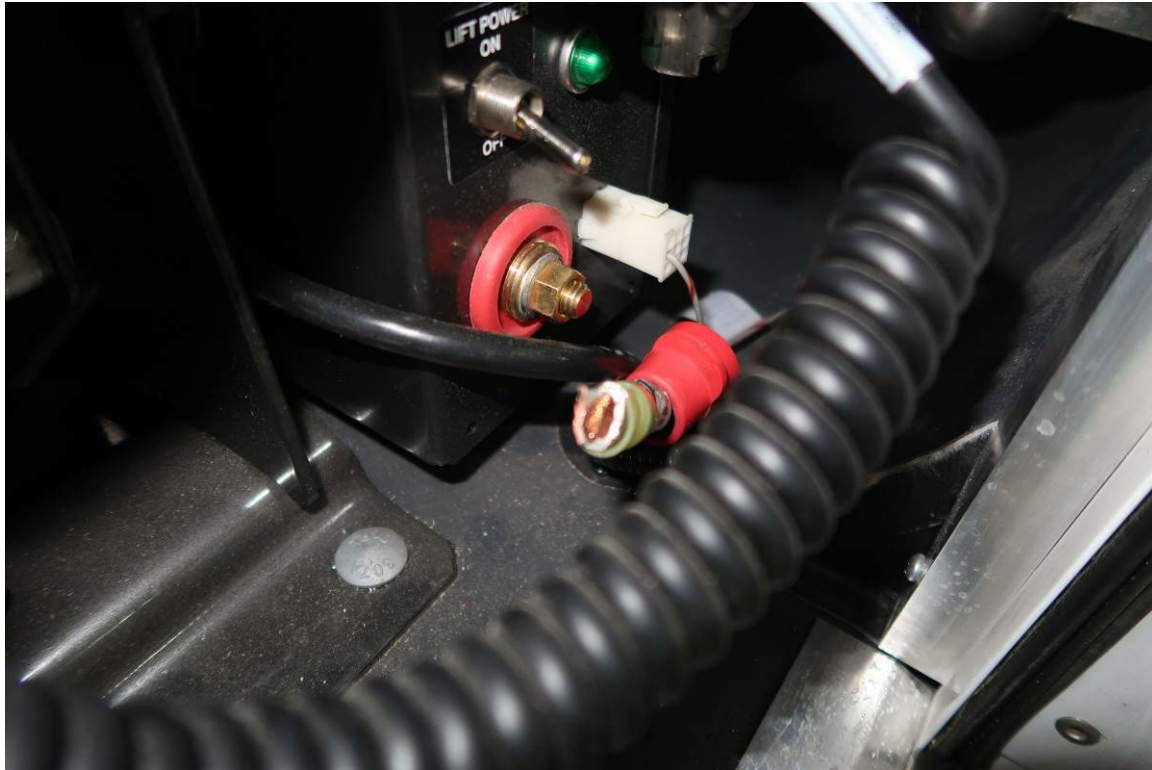
**12-VOLT POWER SUPPLY CABLE BROKE AT THE ADA LIFT  
(2,766 TEST MILES)**

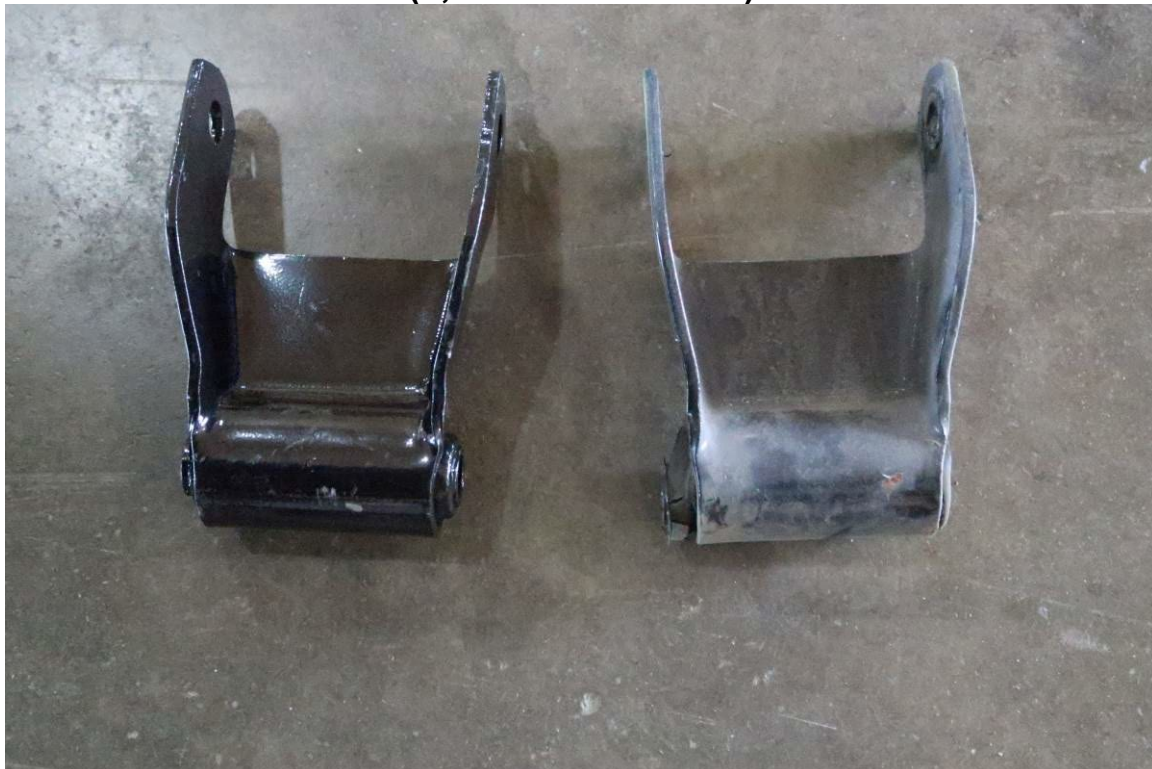
**REPLACEMENT SPRING SHACKLE (LEFT) / WORN STREETSIDE  
REAR SPRING SHACKLE (RIGHT)  
(3,551 TEST MILES)**

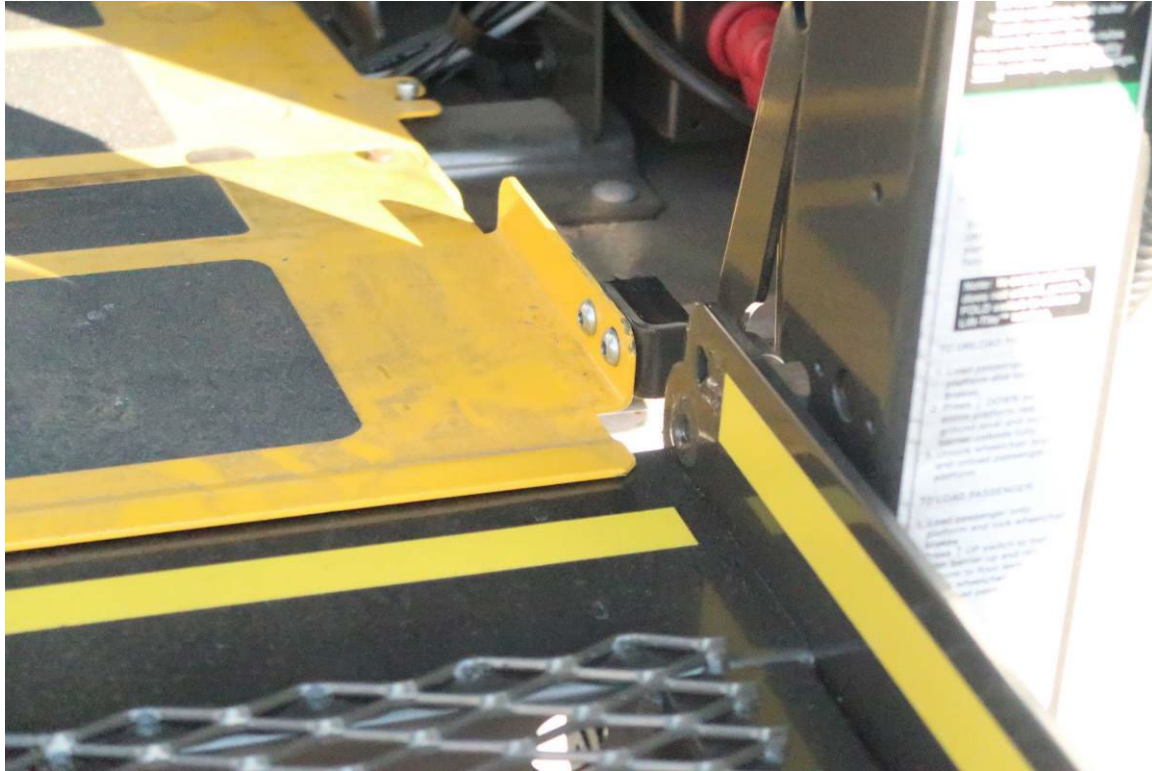
**BOLTS FELL OUT OF INNER BARRIER ON ADA LIFT  
(3,705 TEST MILES)**

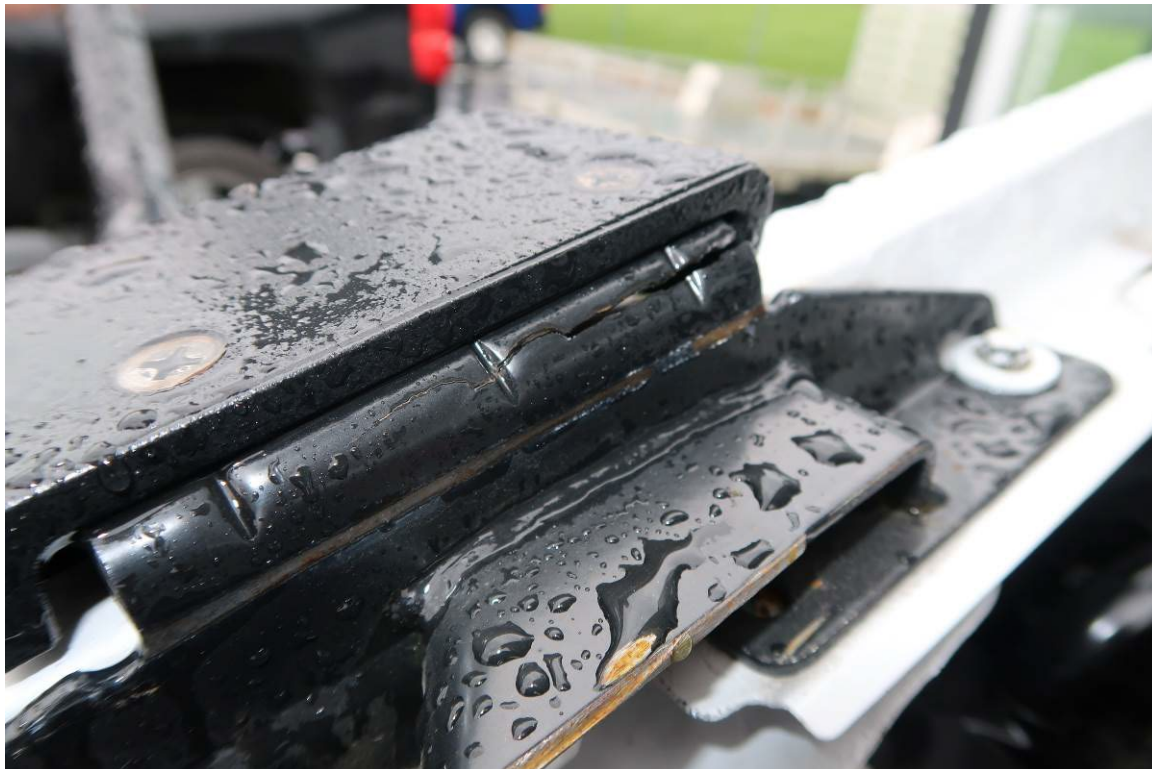
**CURBSIDE FRONT MIRROR BRACKET IS CRACKED  
(4,183 TEST MILES)**

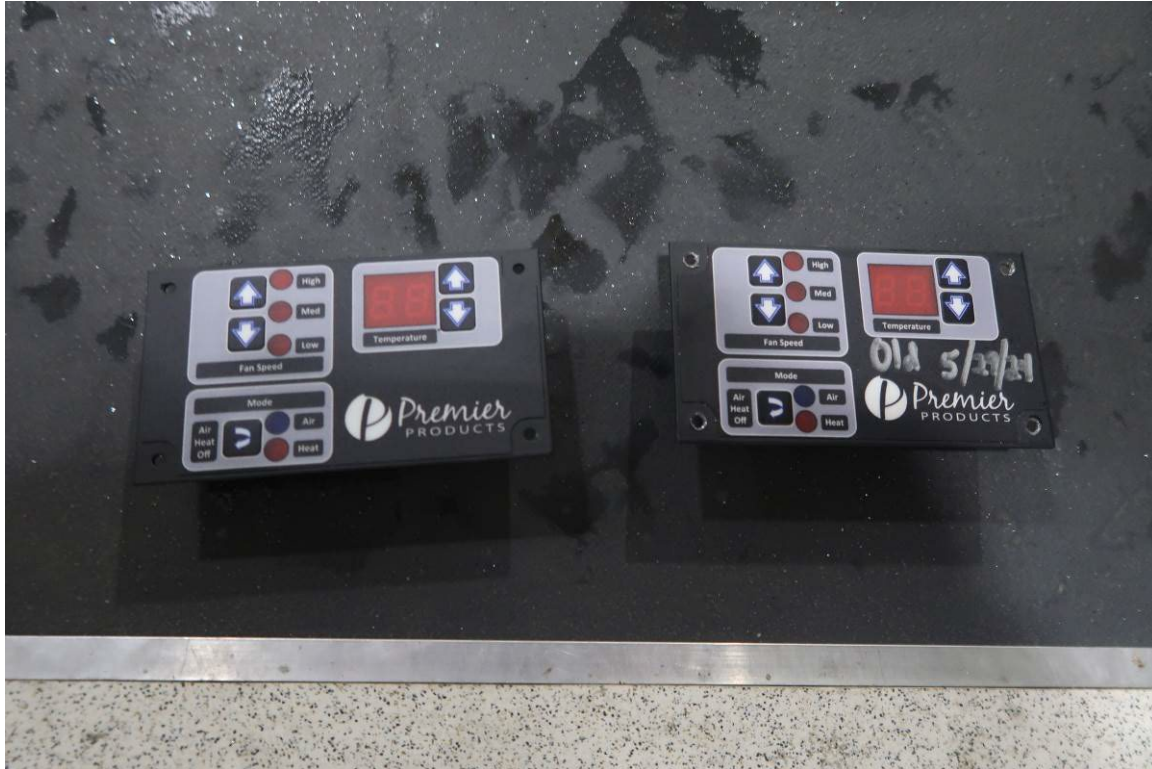
**DEFECTIVE CONTROL BOARD FOR REAR A/C REPLACED  
(4,183 TEST MILES)**

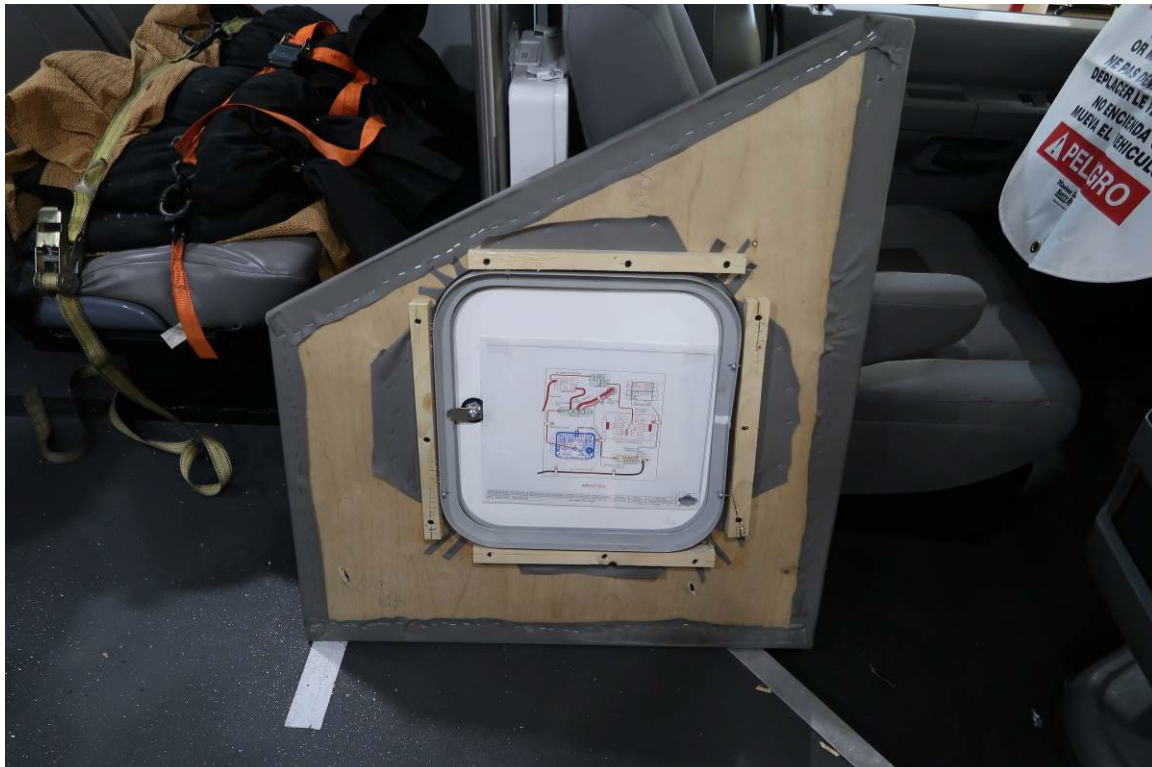
**ELECTRICAL SYSTEM COVER PANEL ABOVE DRIVER FELL DOWN  
(4,183 TEST MILES)**

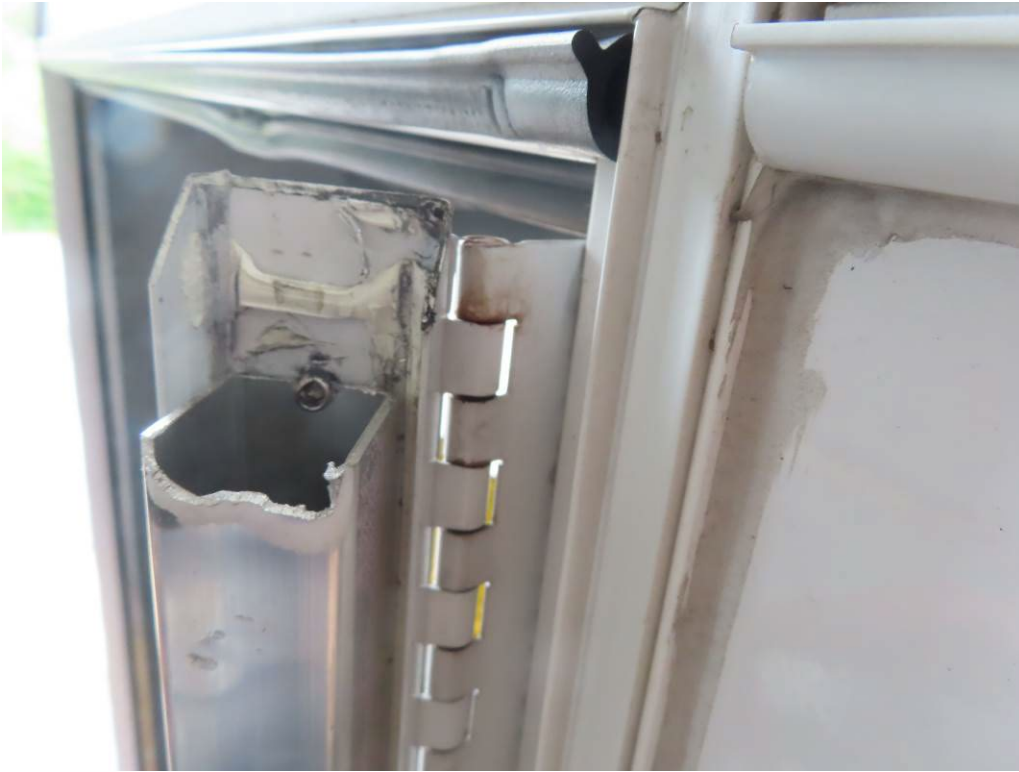
**BROKEN PART OF ADA DOOR THAT FELL OFF  
(4,579 TEST MILES)**

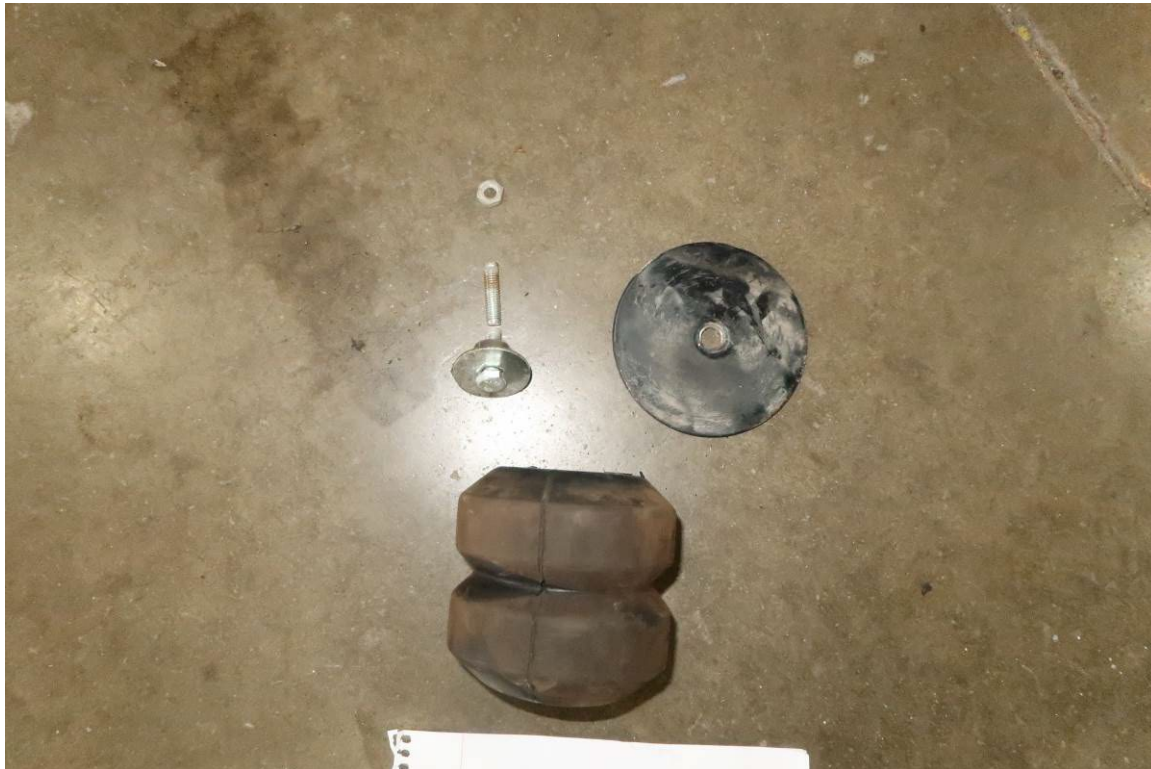
**FRONT CURBSIDE BUMP STOP BROKE AND FELL OFF  
(4,781 TEST MILES)**

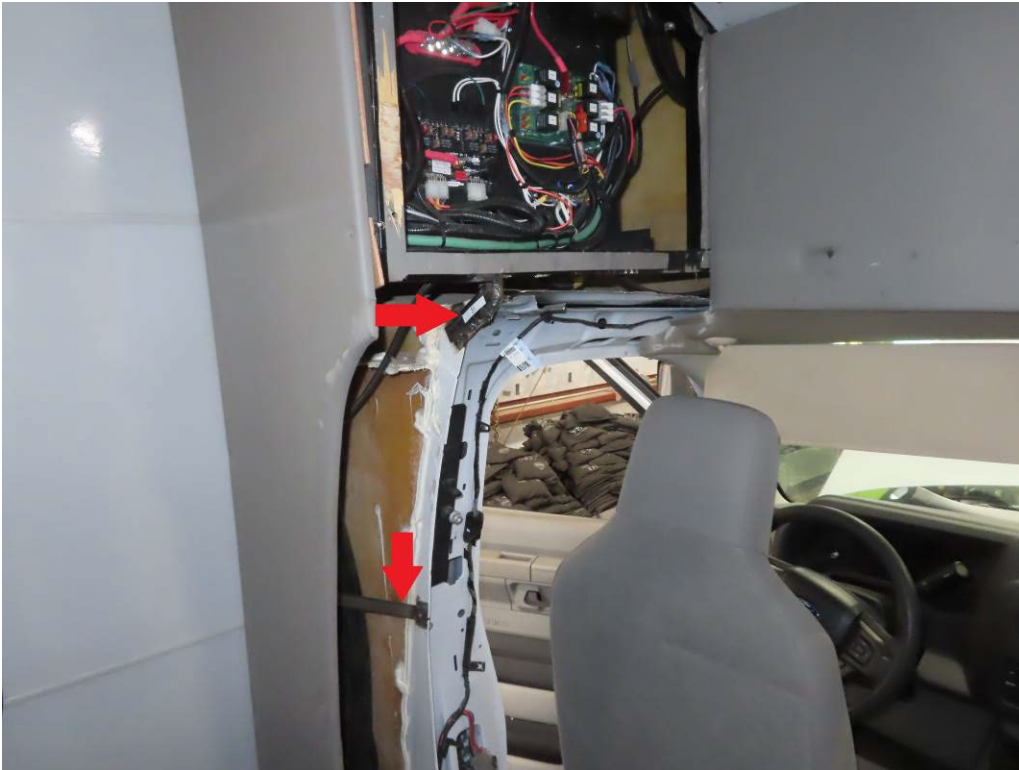
**LOCATION OF CRACK #31 AND NEW SUPPORT STRAP  
(4,975 TEST MILES)**

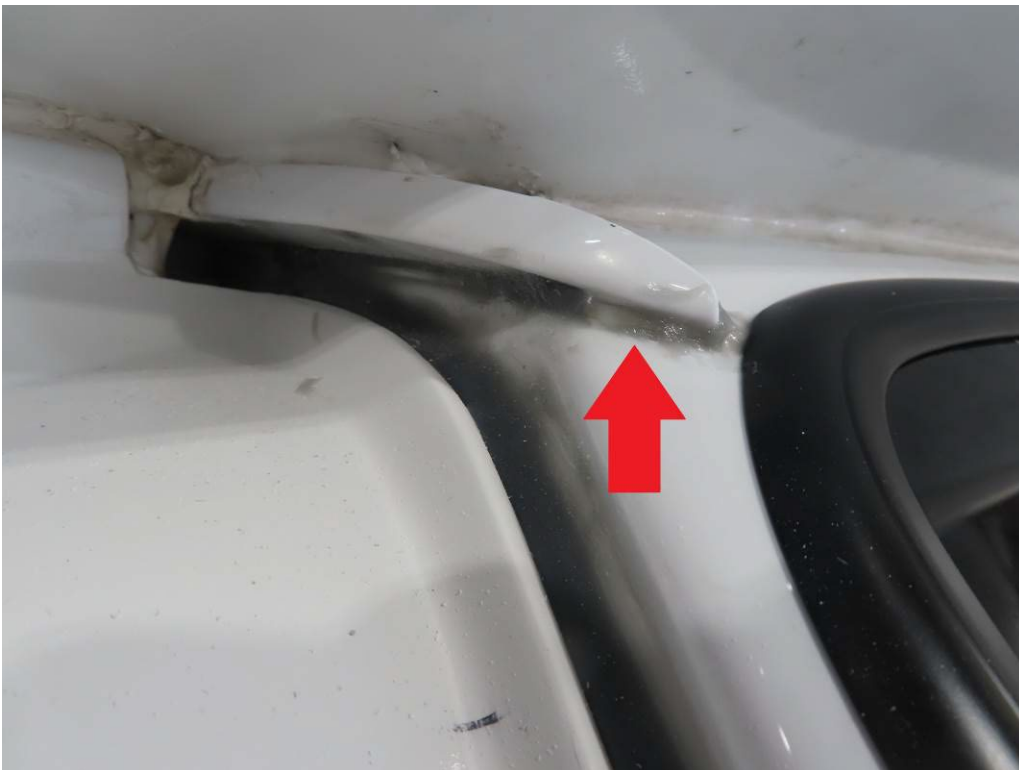
**CRACK #33 AT CURBSIDE TOP OF WINDSHIELD  
REPAIRED WITH EPOXY AND SILICONE  
(4,975 TEST MILES)**
