# **FEDERAL TRANSIT BUS TEST**

**Manufacturer: High Level Enterprises, Inc.  
Model: 16 + 2WC**

**November 2024**

**Report Number: LTI-BT-R2024-04**

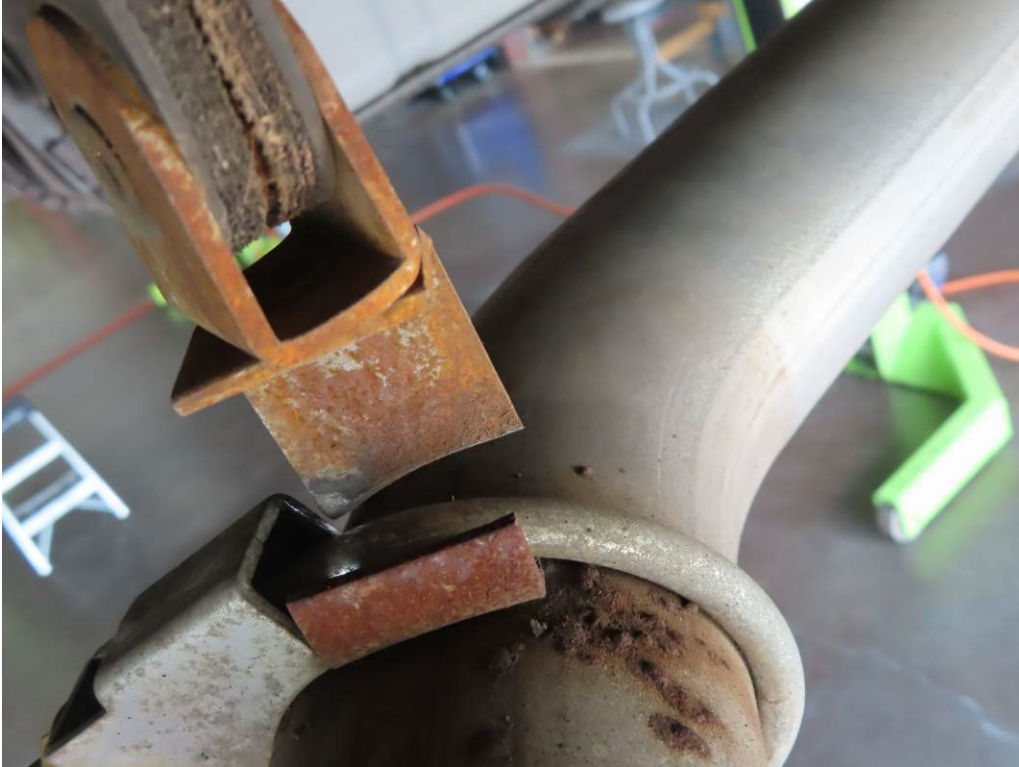
**EXHAUST HANGER ON STREETSIDE HAS CRACKED AND SEPARATED  
(5,533 TEST MILES)**

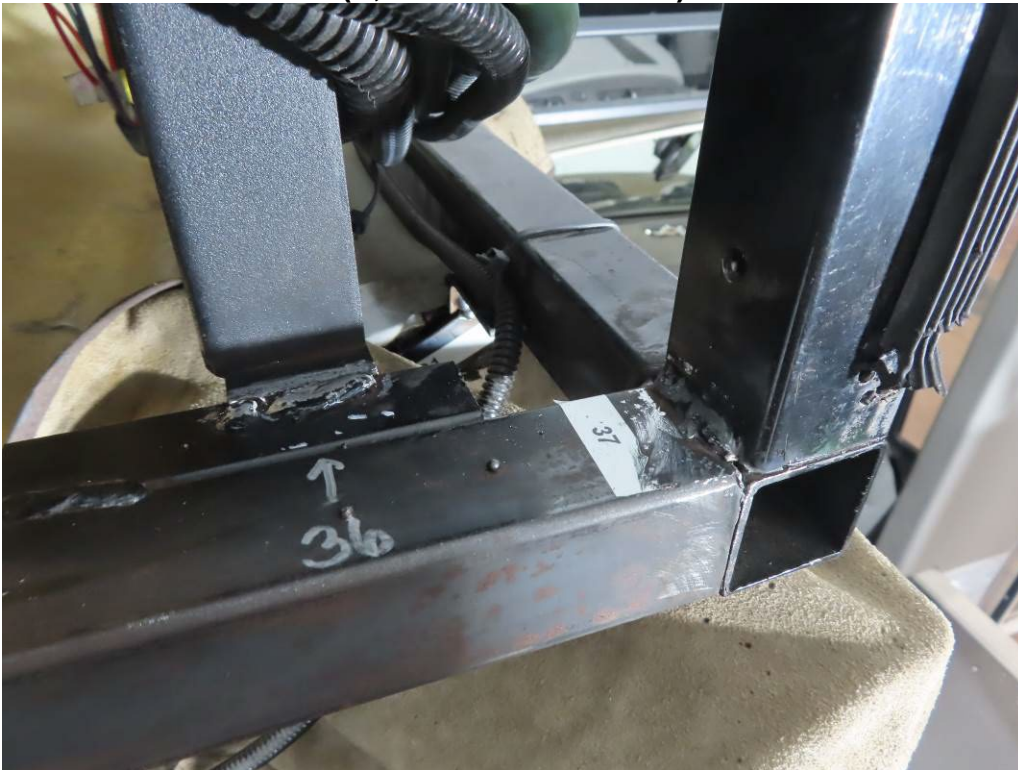
**CRACK #36 & 37– VERTICAL SUPPORT AND HORIZONTAL  
TUBING THAT FRAMES THE FUSE PANEL  
(6,207 TEST MILES)**

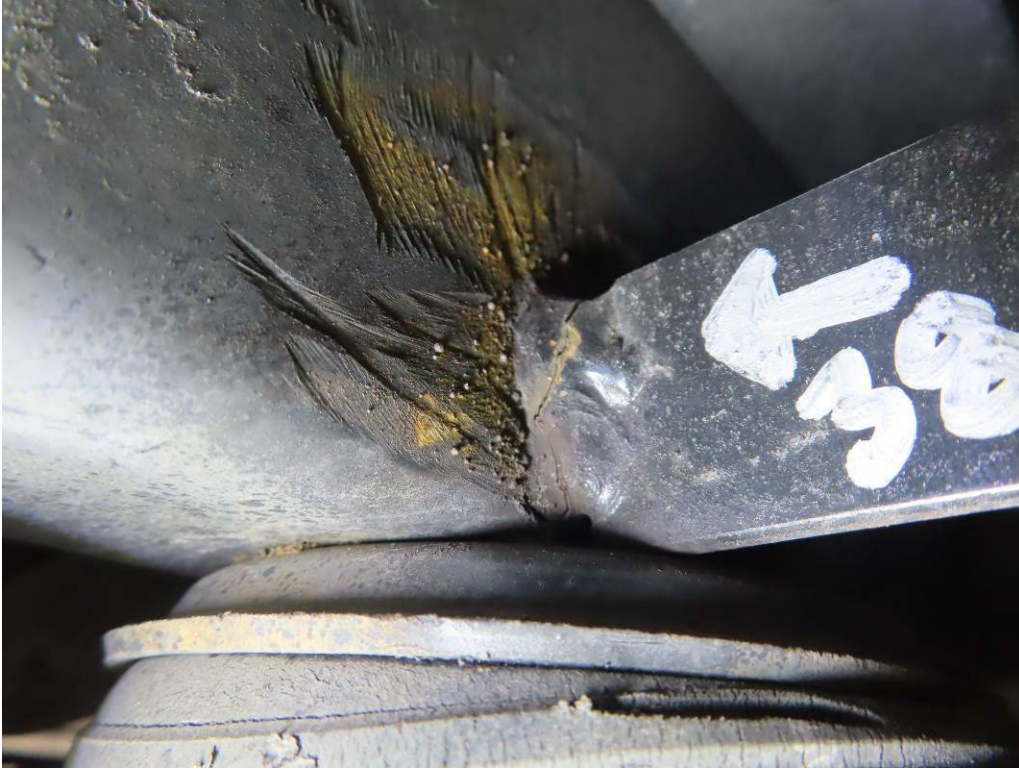
| DATE | TEST MILES | SERVICE | ACTIVITY/OBSERVATIONS | DOWN TIME | LABOR HOURS |
|---|---|---|---|---|---|
| 09/13/24<br>(Cont.) | | | <p>A 2 cm crack has developed on the curbside behind Crack #23-2, the whole weld is broken (Crack #38).<br/>The curbside heatshield has cracked (Crack #39).<br/>There is a crack and spotweld break in the curbside inner core support inner fender area next to 12-volt battery and curbside mirror mounting bolt area (Crack #40).<br/>There is a crack in the curbside inner fender behind A/C line near the A/C filter (Crack #41).<br/>A crack developed in the streetside upper corner of the windshield near the drip edge (Crack #42).<br/>A 1 cm crack has developed under the curbside front mirror mount (Crack #43).<br/>A 3 cm crack has developed at the curbside bottom of the dogbox perimeter (Crack #44).<br/>A 5 cm crack has developed at the curbside bottom of the dogbox perimeter (Crack #45).<br/>A 3 cm crack developed at the spotweld adjacent to Crack #45 (Crack #46).<br/>There is a 2.5 cm crack in the curbside inner fender near the brake booster (Crack #47).<br/>There is a crack in the weld on the heatshield above the curbside frame rail inside body mount, just forward of Crack #27-2 (Crack #48).<br/>A crack has developed on the heatshield above the curbside body mount behind the battery box mounted on the frame rail (Crack #49).<br/>A crack has developed in the body above the frame rail between the body mounts behind the curbside front tire (Crack #50).<br/>New Cracks observed this PM:<br/>The twice repaired crack in the body below the driver's seat has cracked again (Crack #4-3).<br/>A 2cm crack in the curbside inner fender under battery holder (Crack #51).</p> | | |

**CRACK #38 –CURBSIDE HEATSHIELD, WELD IS BROKEN  
(6,207 TEST MILES)**

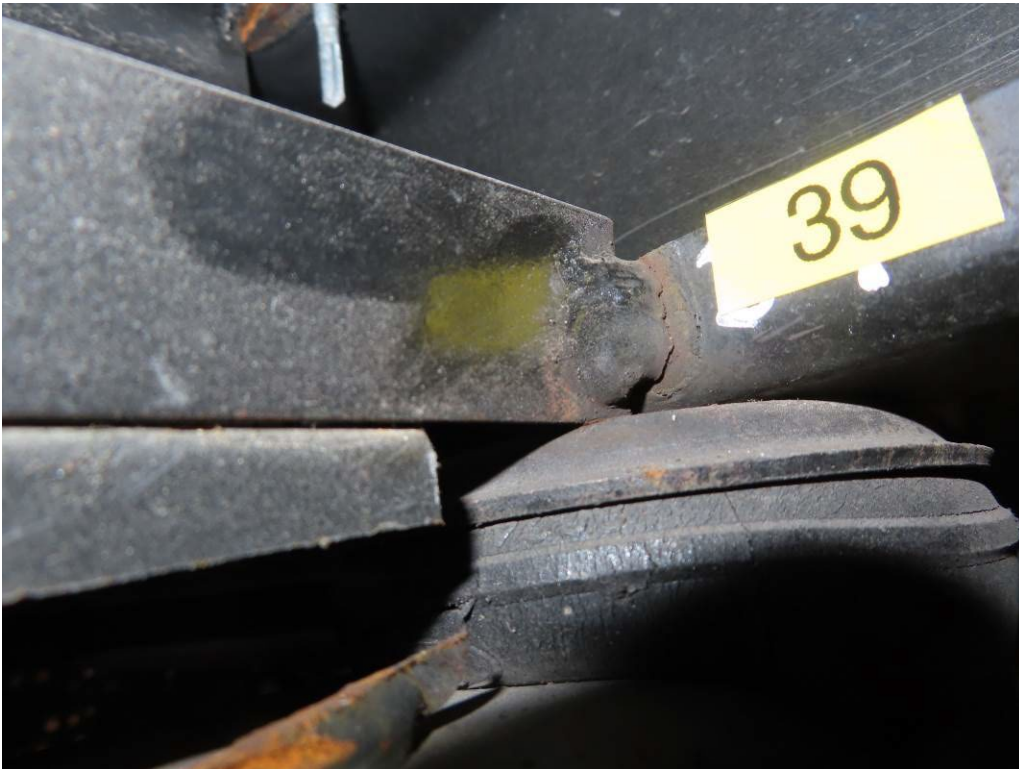
**CRACK #39 – CRACK ON THE HEATSHIELD  
(6,207 TEST MILES)**

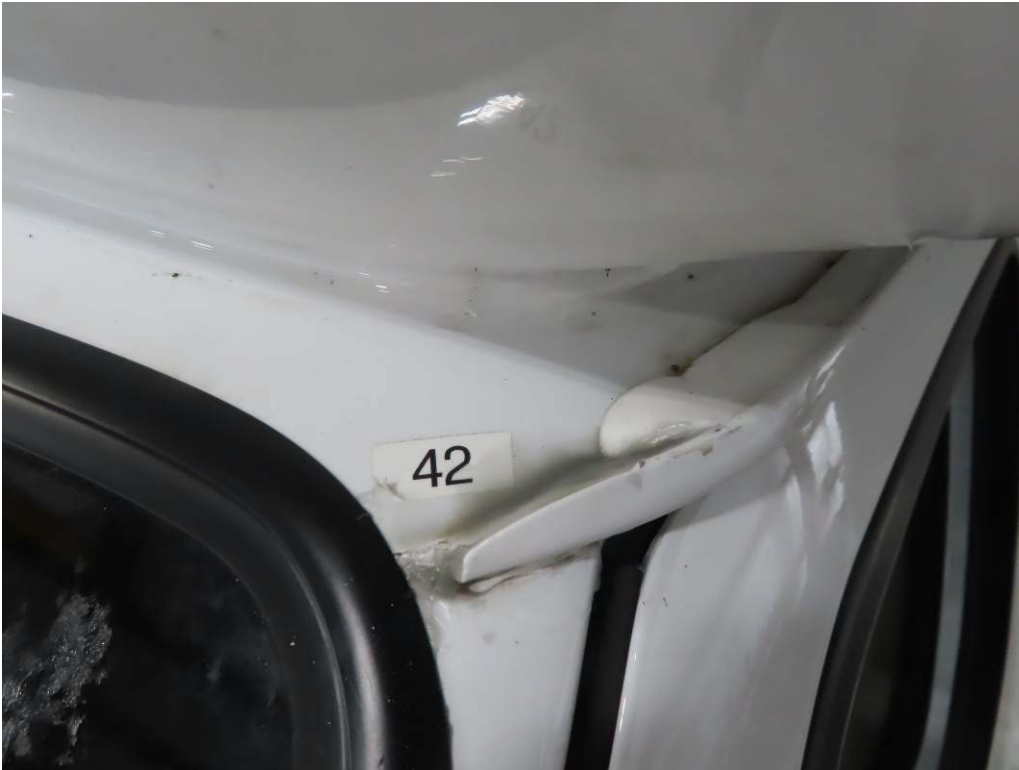
**CRACK #42 – A CRACK IN THE STREETSIDE UPPER CORNER OF THE WINDSHIELD NEAR THE DRIP EDGE  
(6,207 TEST MILES)**

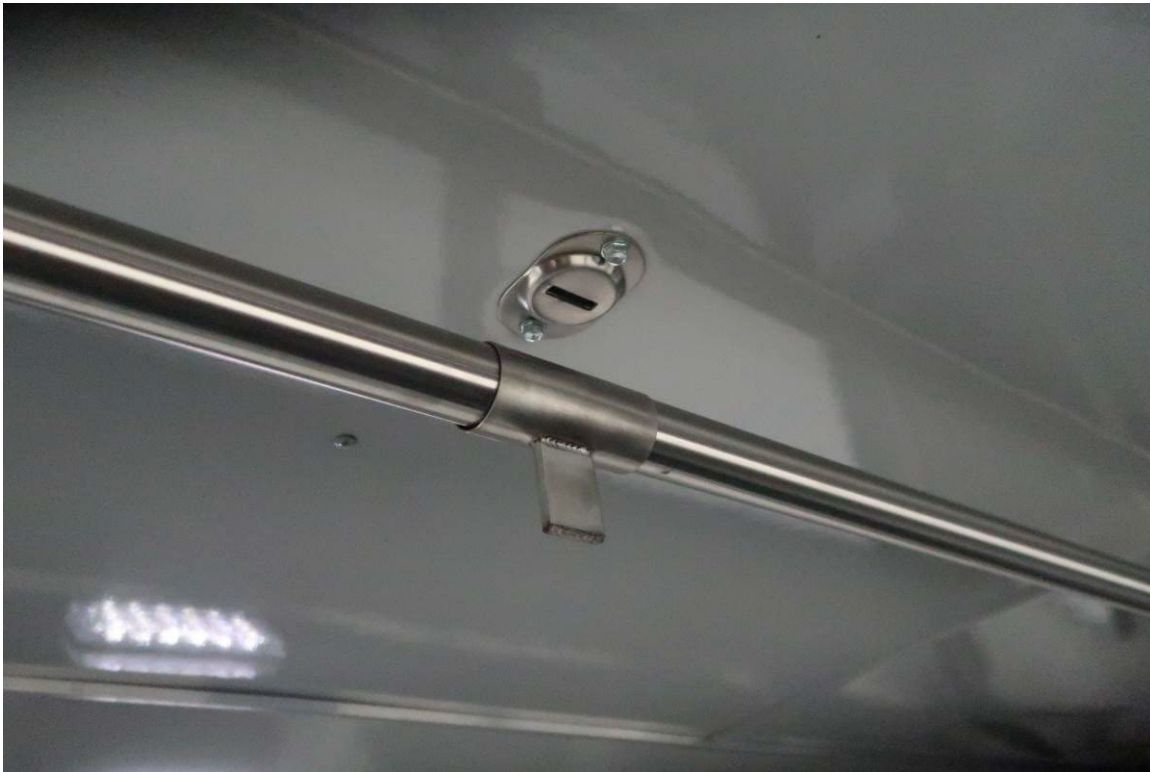
**BROKEN WELD ON CURBSIDE GRAB HANDRAIL  
(7,034 TEST MILES)**

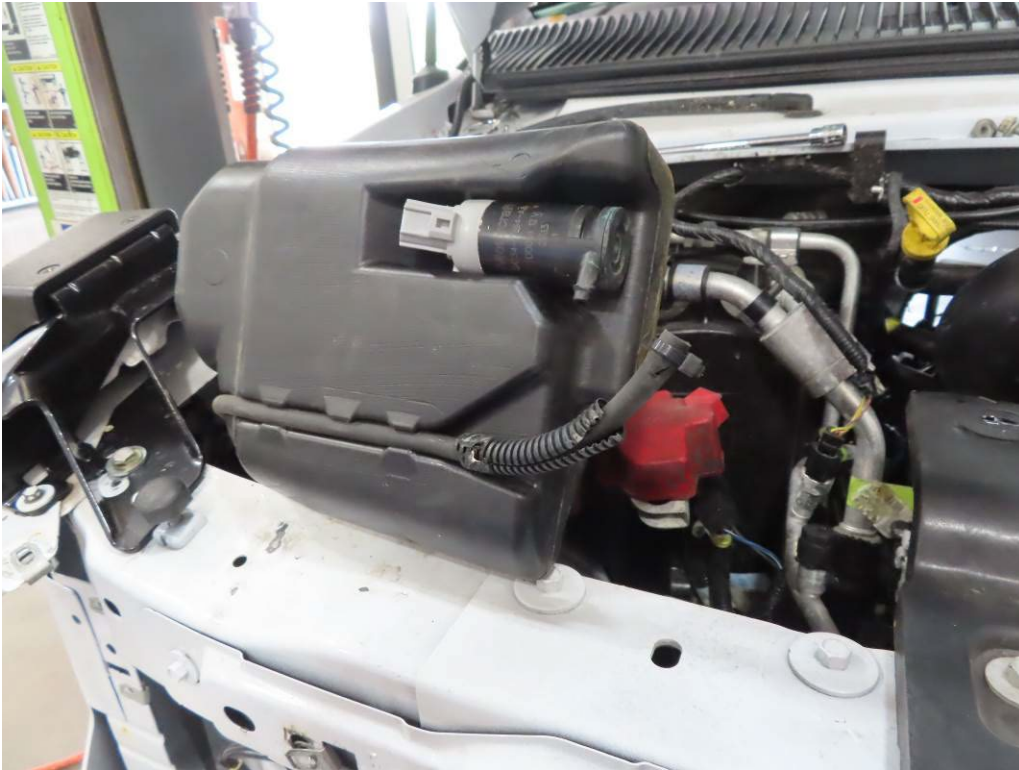
**DAMAGED HOSE ON WASHER TANK  
(7,486 TEST MILES)**

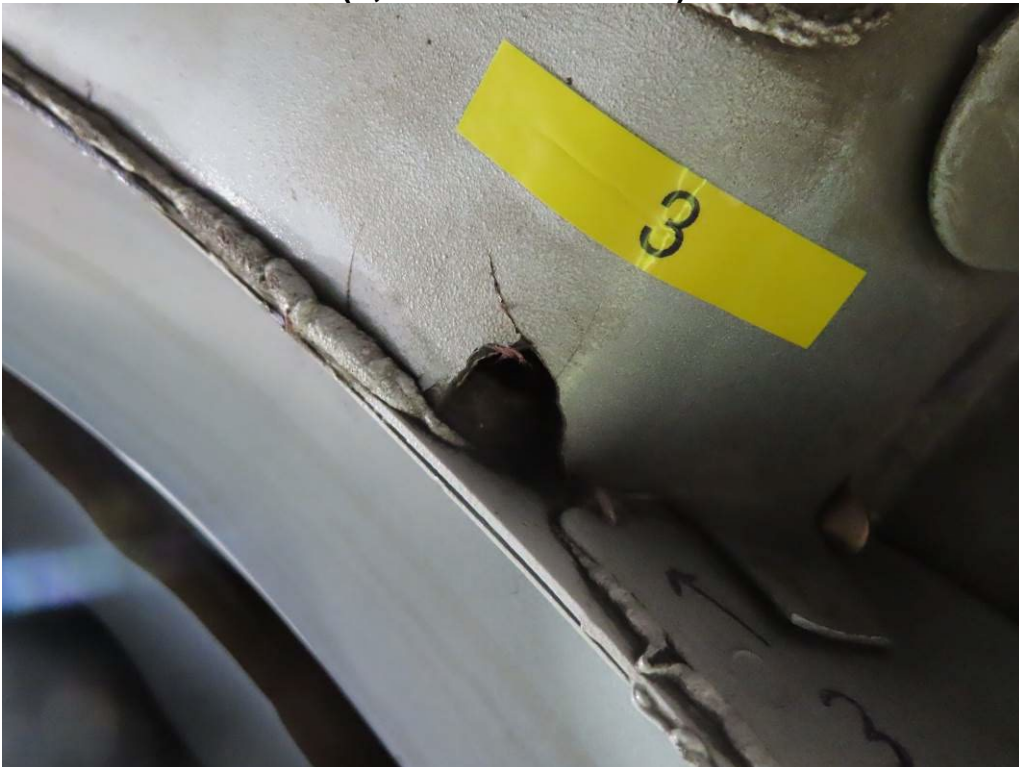
**CRACK #3 – FRONT CURBSIDE INNER FENDER IS PULLING  
AWAY/CRACKED ON THE REAR LOWER SIDE  
(7,486 TEST MILES)**

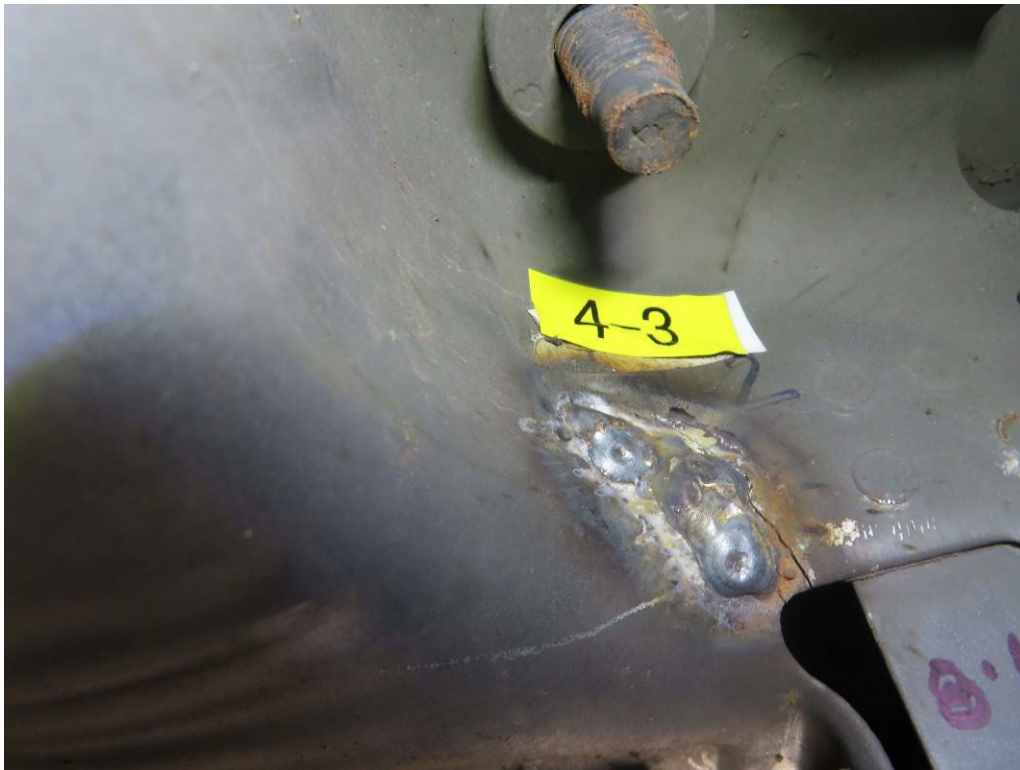
**CRACK #4-3 – PREVIOUSLY WELDED CRACK IN BODY BELOW REAR  
LEFT DRIVER’S SEAT BOLT CRACKED AGAIN  
(7,486 TEST MILES)**

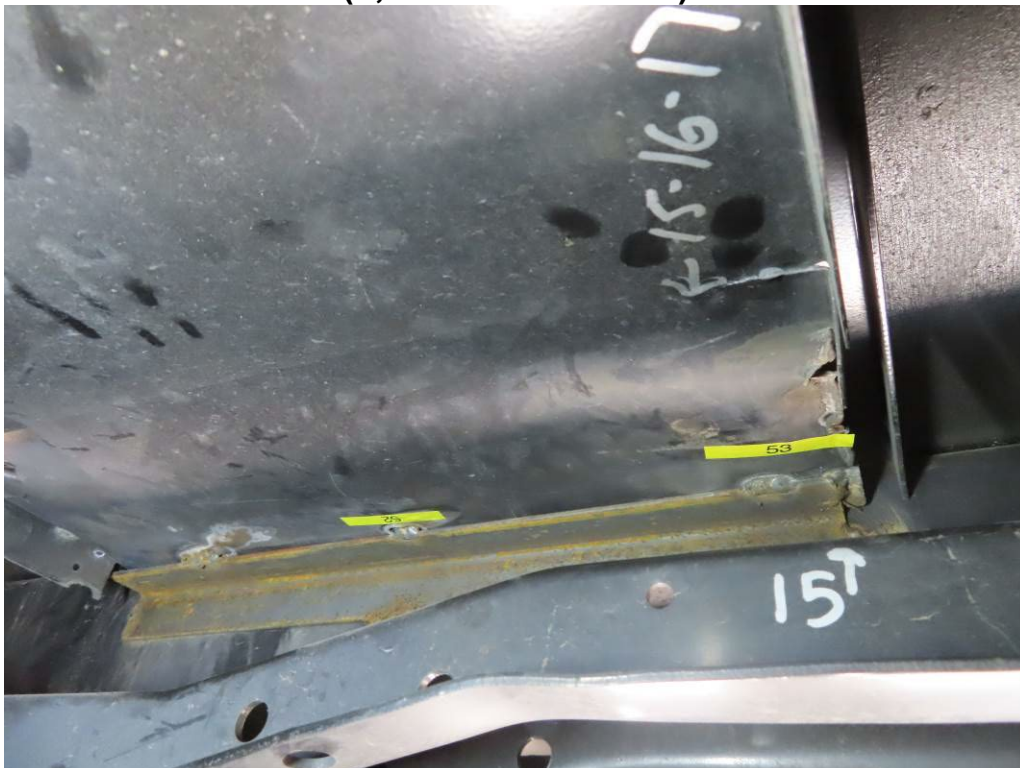
| DATE | TEST MILES | SERVICE | ACTIVITY/OBSERVATIONS | DOWN TIME | LABOR HOURS |
|---|---|---|---|---|---|
| 09/13/24<br>(Cont.) | | | <p>Rear heatshield welds above the horizontal crossmember are cracked (Cracks #52 &amp; 53).</p> <p>A group of 1cm cracks in the body behind the grille in front of the A/C condenser (Cracks #54-57).</p> <p>A crack approximately 1 cm in size has formed above the front curbside coil spring on the inner fender (Crack #58). The steel strap welded to the body behind the driver has cracked (Crack #59).</p> <p>Back topside of inner curbside fender is cracked (Crack #60).</p> <p>A crack has developed on the streetside body next to the exhaust manifold (Crack #61).</p> <p>A group of spot welds cracked/pulled away in driver's door jamb (Cracks #62-66).</p> | | |

**CRACKS #52 & 53 – CRACKS IN REAR HEATSHIELD  
ABOVE HORIZONTAL CROSSMEMBER  
(7,486 TEST MILES)**

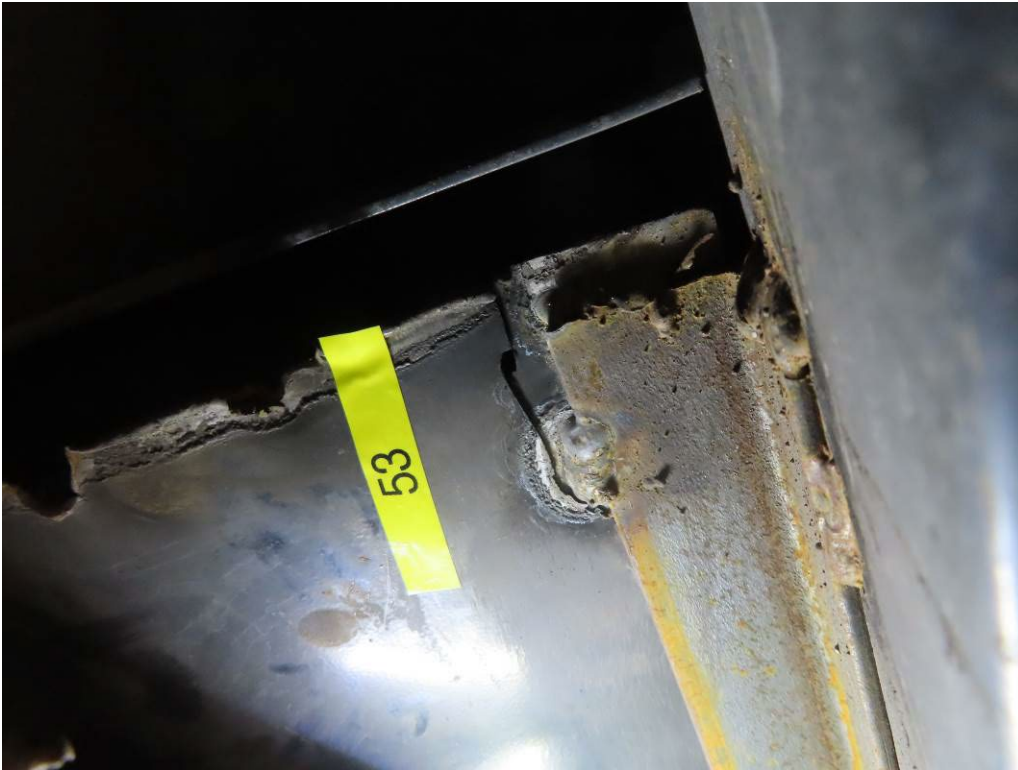
**CRACK #53 – CRACK IN REAR HEATSHIELD  
ABOVE HORIZONTAL CROSSMEMBER  
(7,486 TEST MILES)**

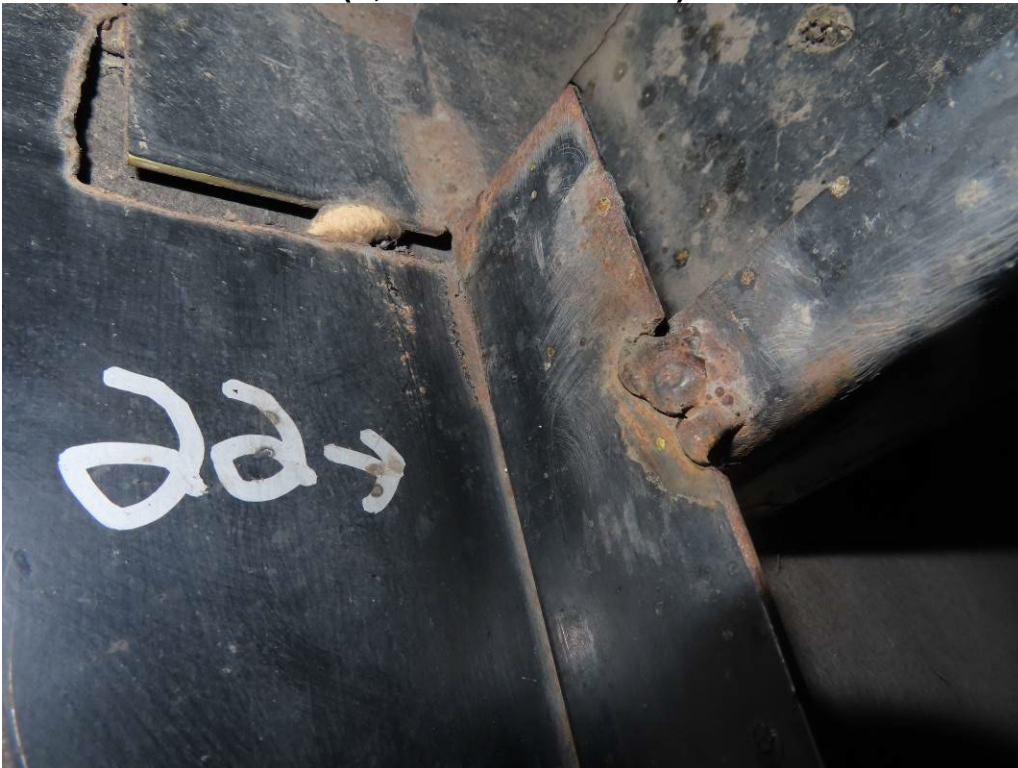
**CRACK #22-2 – CROSSBEAM IN FRONT OF STREETSIDE REAR TIRES  
HAS A BROKEN WELD THAT WAS PREVIOUSLY REPAIRED  
(7,486 TEST MILES)**

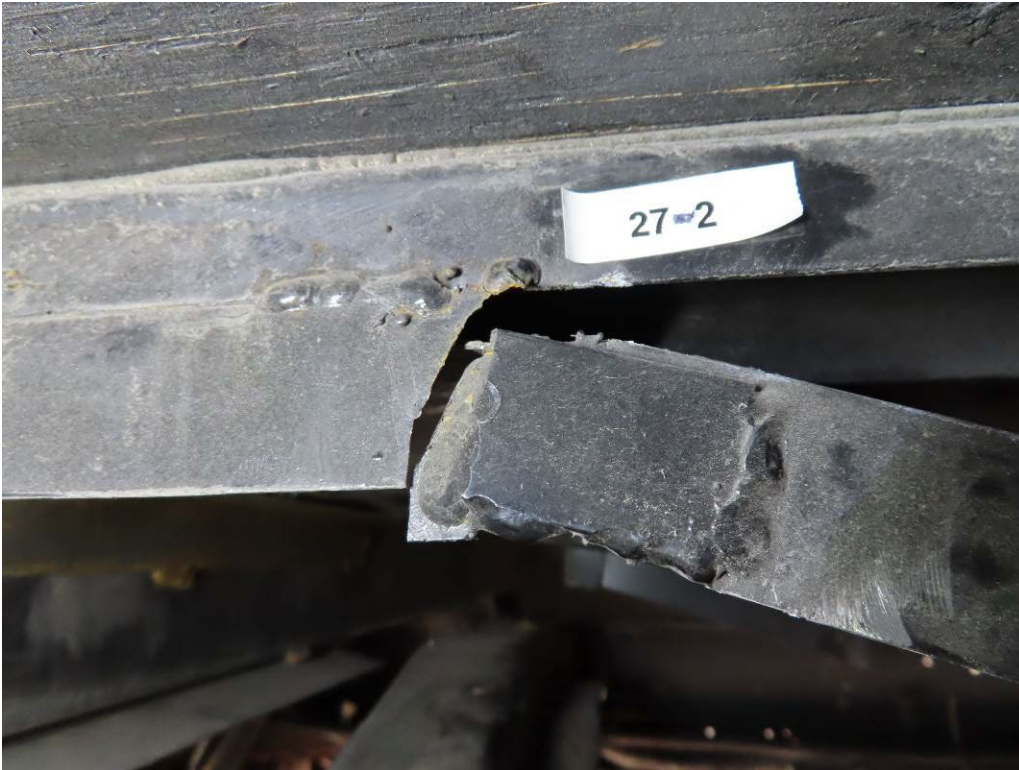
**CRACK #27-2 – PREVIOUSLY REPAIRED SPLIT IN HEATSHIELD  
CRACKED AGAIN  
(7,486 TEST MILES)**

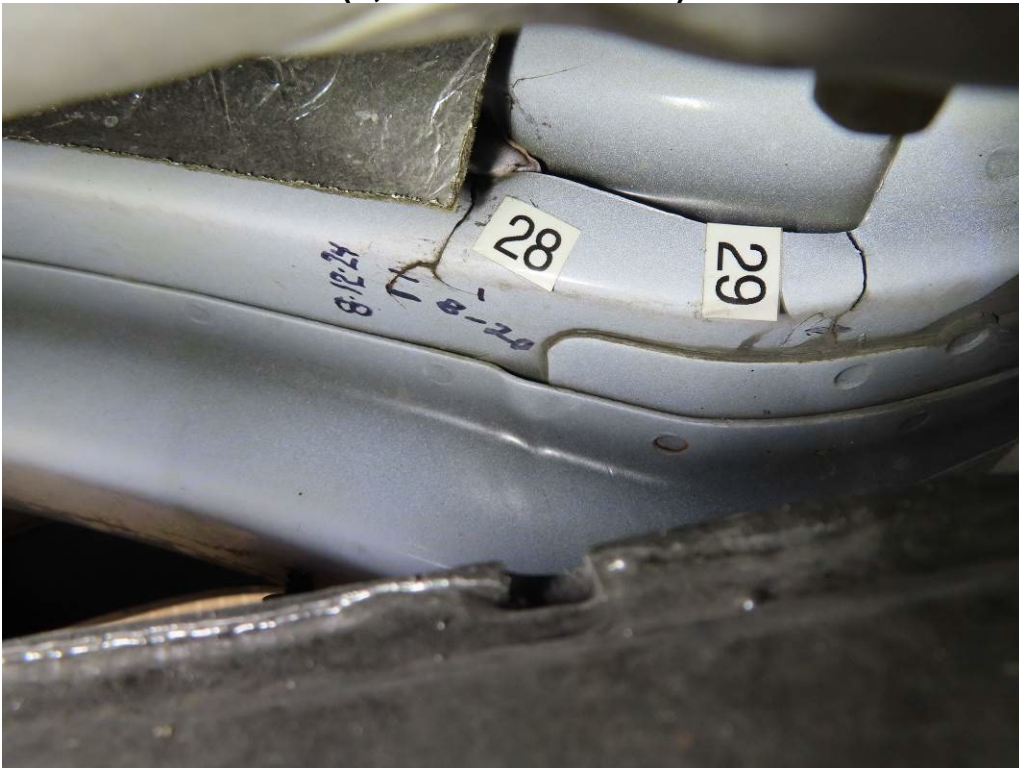
| DATE | TEST MILES | SERVICE | ACTIVITY/OBSERVATIONS | DOWN TIME | LABOR HOURS |
|---|---|---|---|---|---|
| 08/20/24<br>(Cont.) | | | Crack #23-2 – the welded repair attaching the heatshield to the body has broken away.<br>Cracks #28 and #29 have further migrated.<br>Crack #35 has grew 1 ½ cm and the spot weld has pulled out.<br>New Cracks observed:<br>The fuse/relay panel above driver and vertical support which frames the fuse panel has cracked at the bottom where welded to the tube below it (Crack #36).<br>The horizontal square tubing to which the vertical support (location of Crack #36) is welded has cracked where it is joined to the adjacent tube (Crack #37).<br>A 2 cm crack has developed on the curbside heatshield behind Crack #23-2, the whole weld is broken (Crack #38). | | |

**CRACKS #28 & 29 –ON THE BODY AT THE BACK OF THE CURBSIDE  
FRONT INNER FENDER ABOVE FRAME RAIL  
(7,486 TEST MILES)**

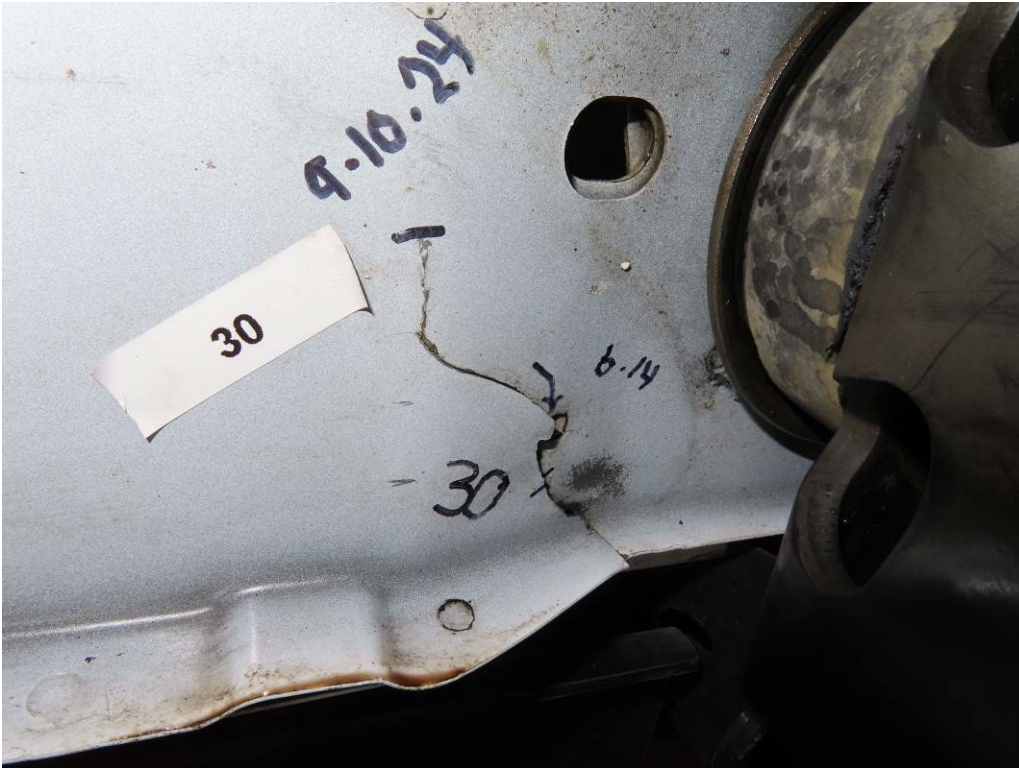
**CRACK #30 – STREETSIDE BODY ABOVE THE FRAME RAIL  
ADJACENT TO THE FORWARDMOST BODY MOUNT BUSHING  
(7,486 TEST MILES)**

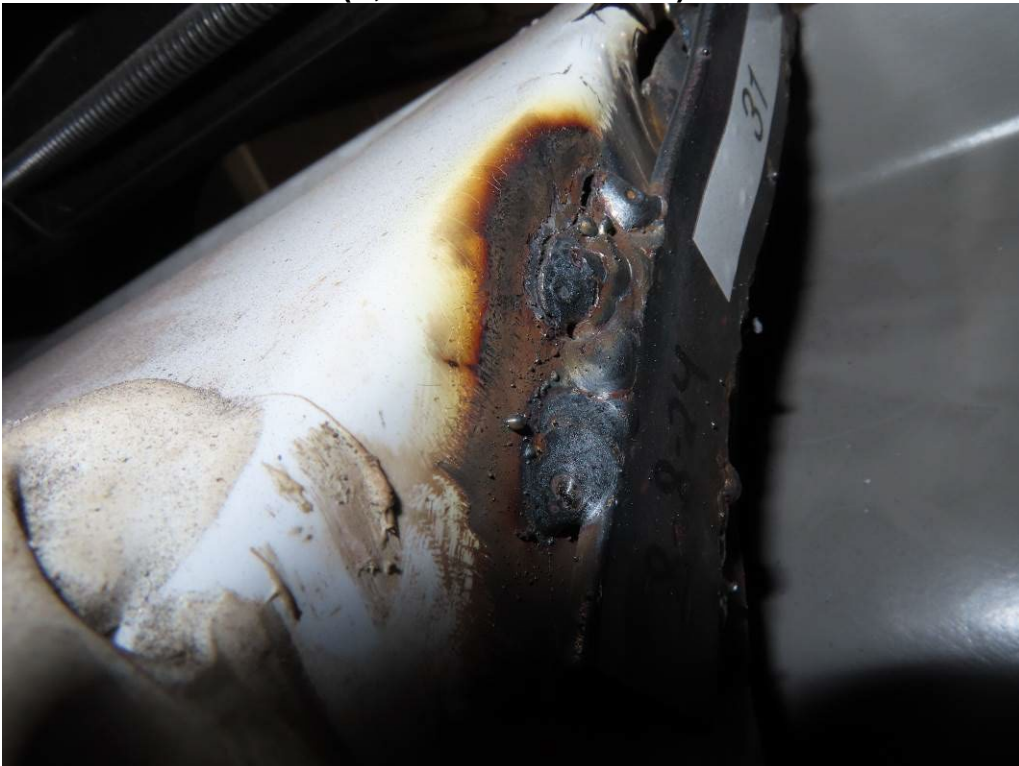
**CRACK #31-2– PREVIOUSLY REPAIRED SUPPORT GUSSET  
ABOVE DRIVER'S DOOR CRACKED AGAIN  
(7,486 TEST MILES)**

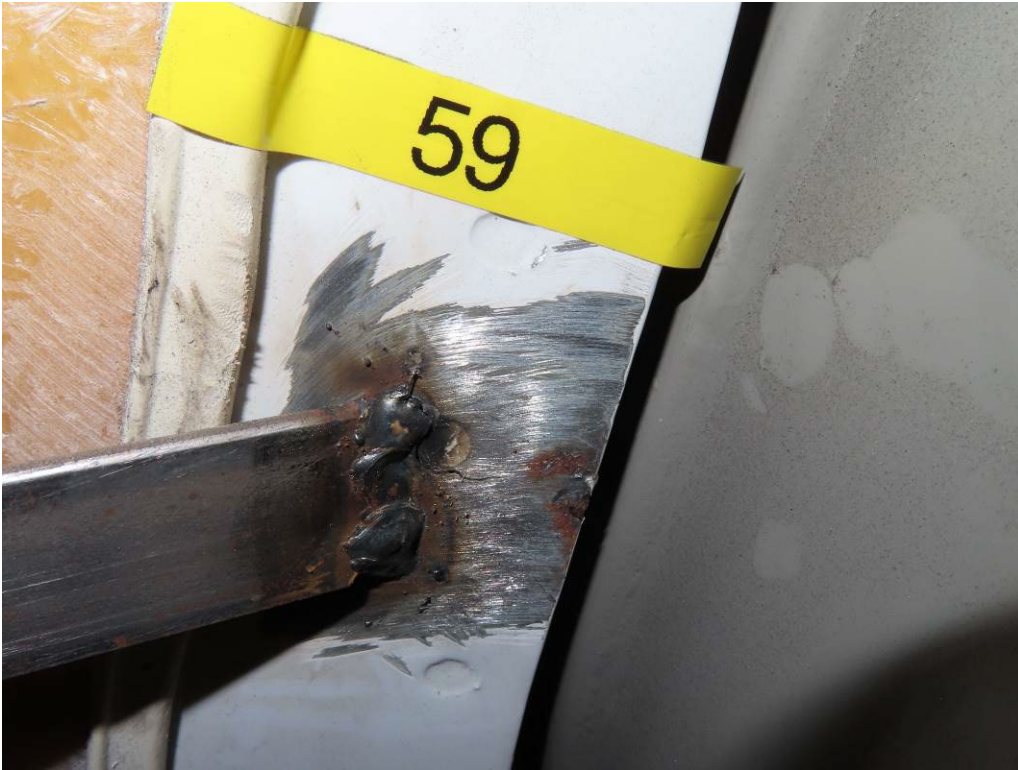
**CRACK #59 – STEEL STRAP THAT WAS ADDED TO BODY  
BEHIND DRIVER HAS CRAKED  
(7,486 TEST MILES)**

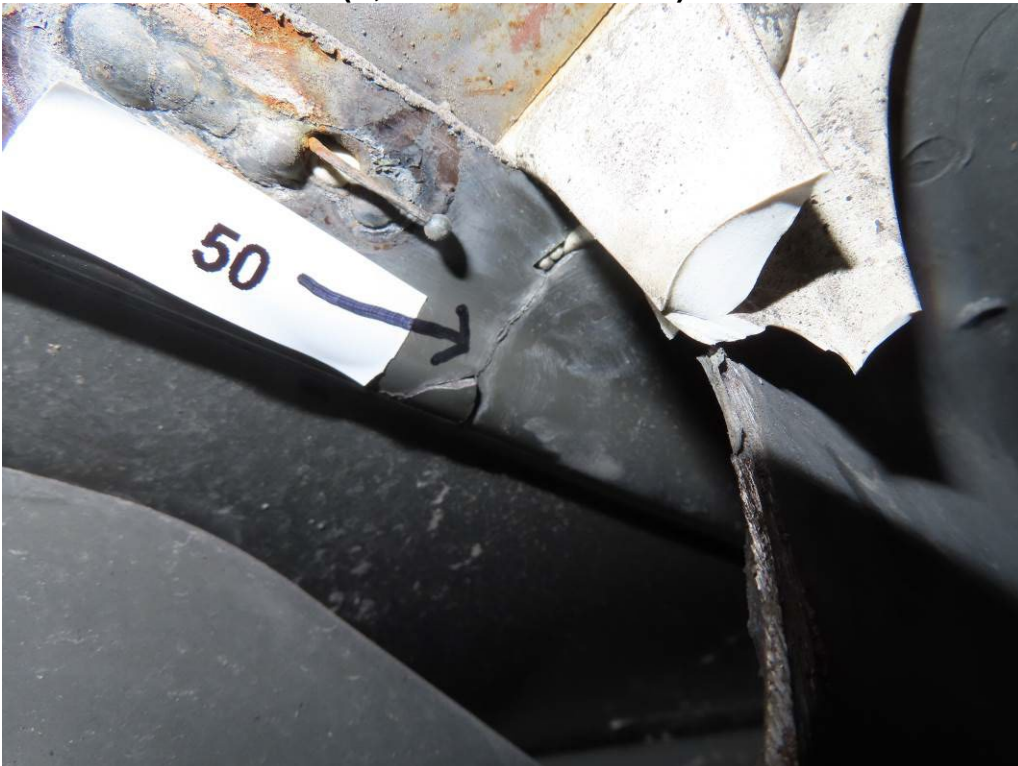
**CRACK #50– BODY ABOVE FRAME RAIL BETWEEN  
BODY MOUNTS BEHIND CURBSIDE FRONT TIRE  
(7,486 TEST MILES)**

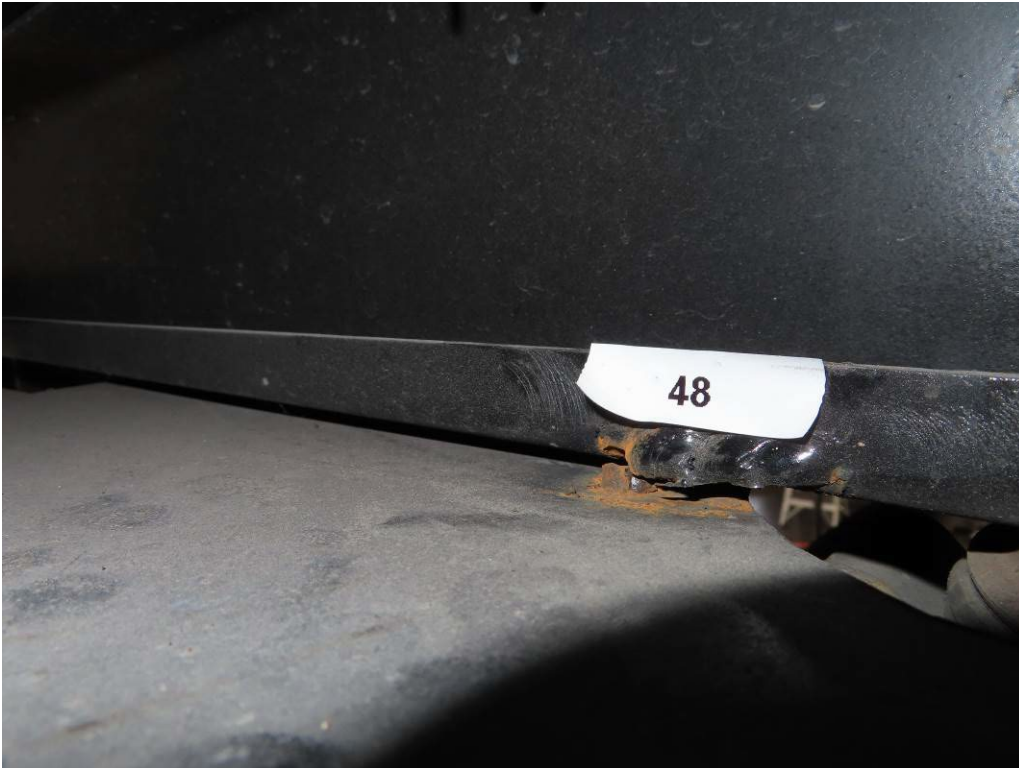
**CRACK #48 – WELD ON THE HEATSHIELD ABOVE CURBSIDE FRAME  
RAIL INSIDE THE BODY MOUNT JUST FORWARD OF CRACK #27-2  
(7,486 TEST MILES)**

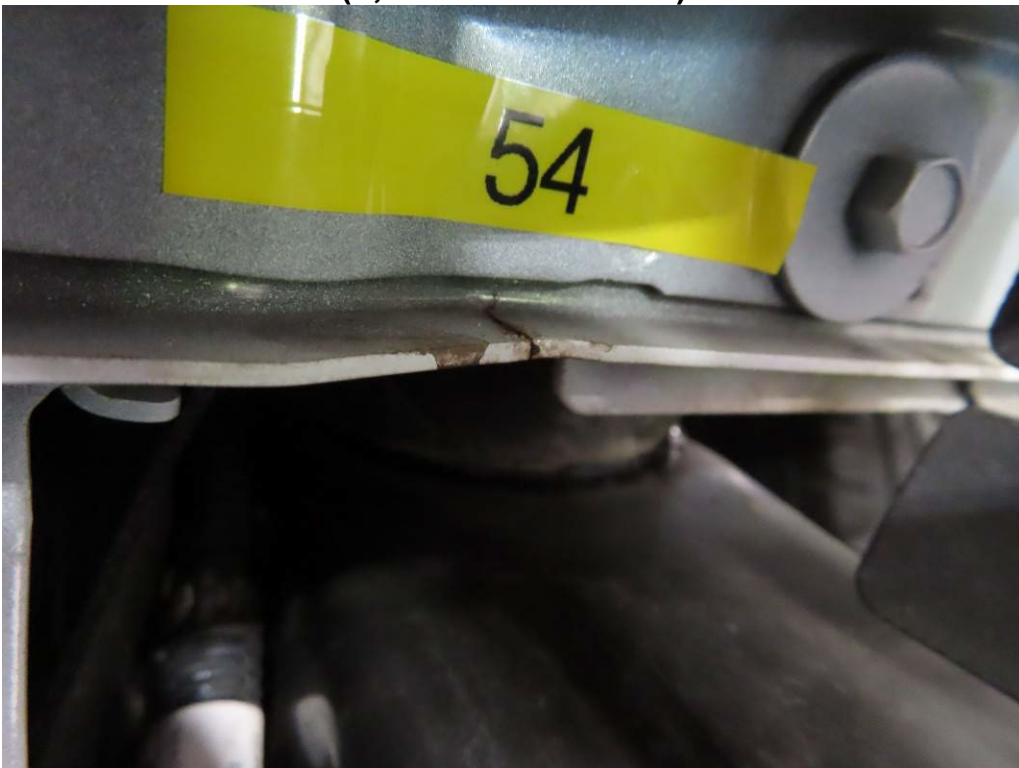
**CRACK #54 – CRACK IN BODY BEHIND GRILLE IN FRONT  
OF THE A/C CONDENSER  
(7,486 TEST MILES)**

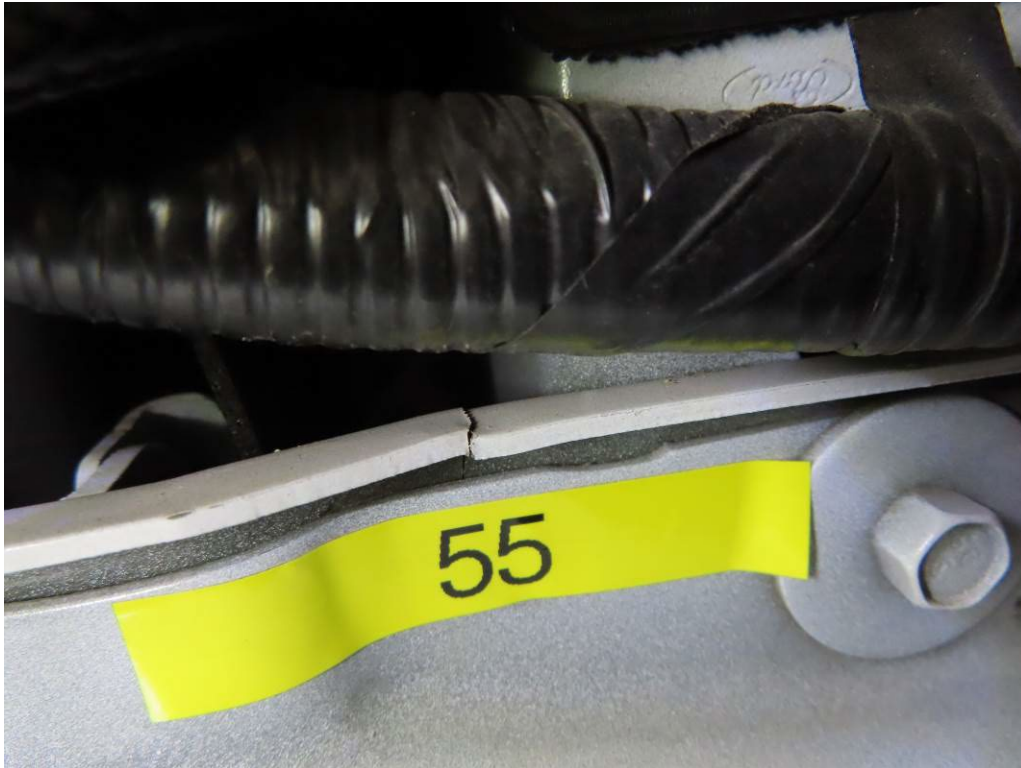
**CRACK #55 – CRACK IN BODY BEHIND GRILLE IN FRONT  
OF THE A/C CONDENSER  
(7,486 TEST MILES)**

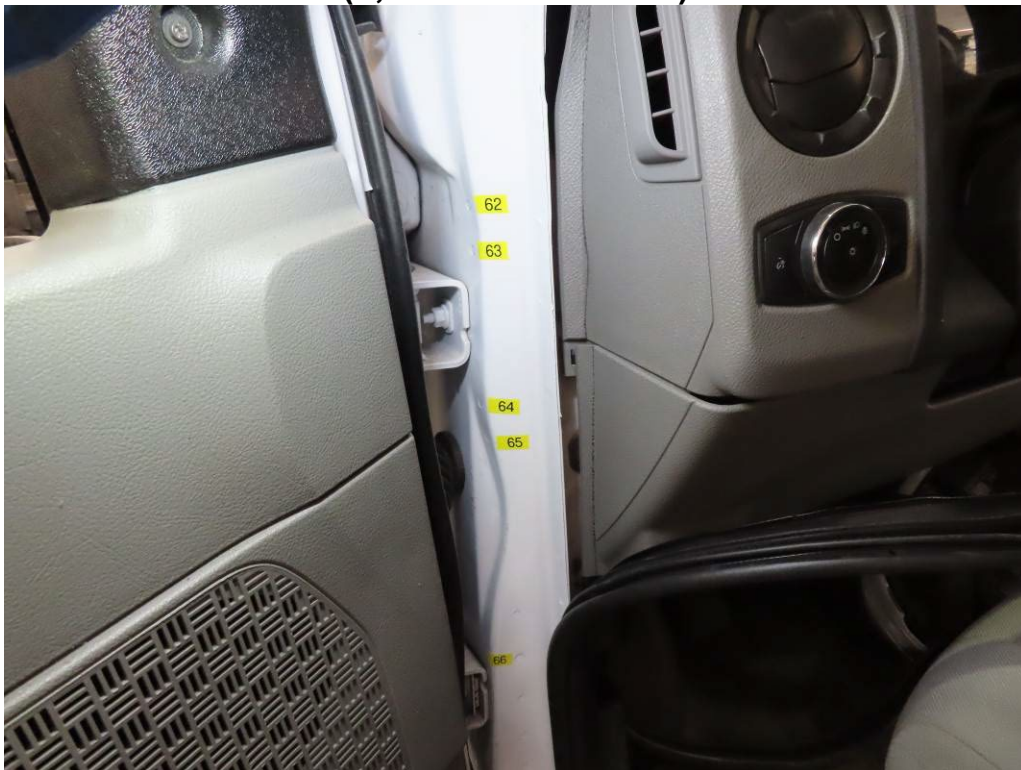
**CRACKS #62, 63, 64 & 65 – LOCATION OF CRACKS IN  
DRIVER'S DOOR JAMB  
(7,486 TEST MILES)**
