# **FEDERAL TRANSIT BUS TEST**

**Manufacturer: High Level Enterprises, Inc.  
Model: 16 + 2WC**

**November 2024**

**Report Number: LTI-BT-R2024-04**

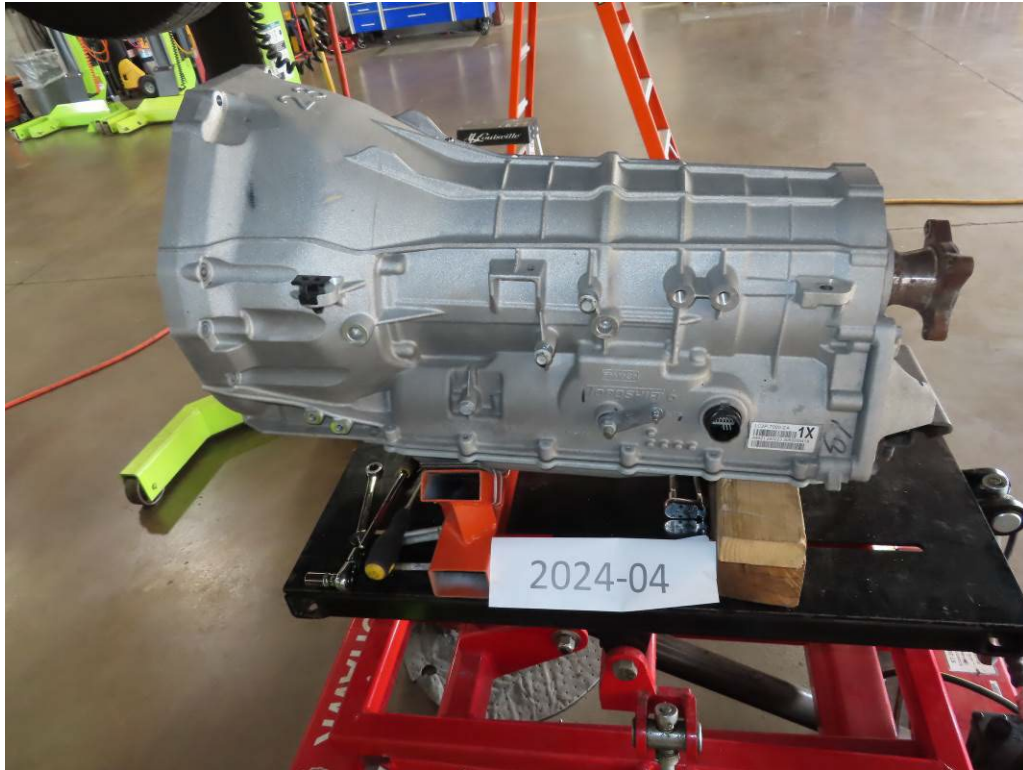
**TRANSMISSION REMOVAL AND REPLACEMENT  
(7.00 LABOR HOURS)**

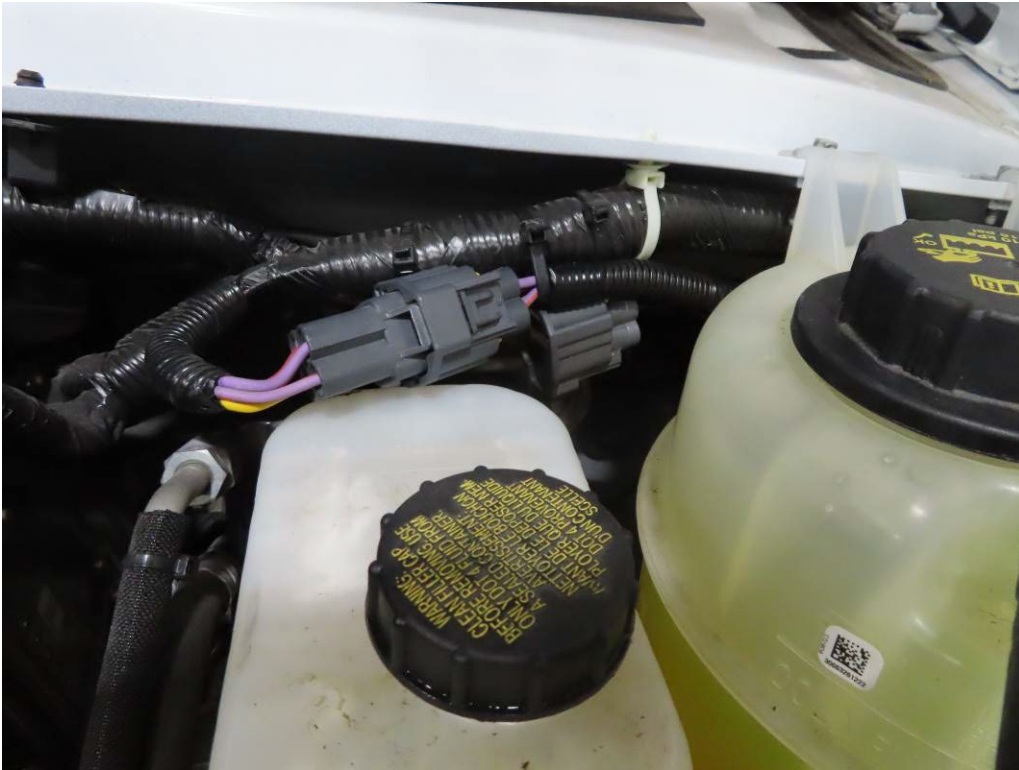
**JUMPER HARNESS FOR HIGH IDLE INSTALLED  
(4,579 TEST MILES)**

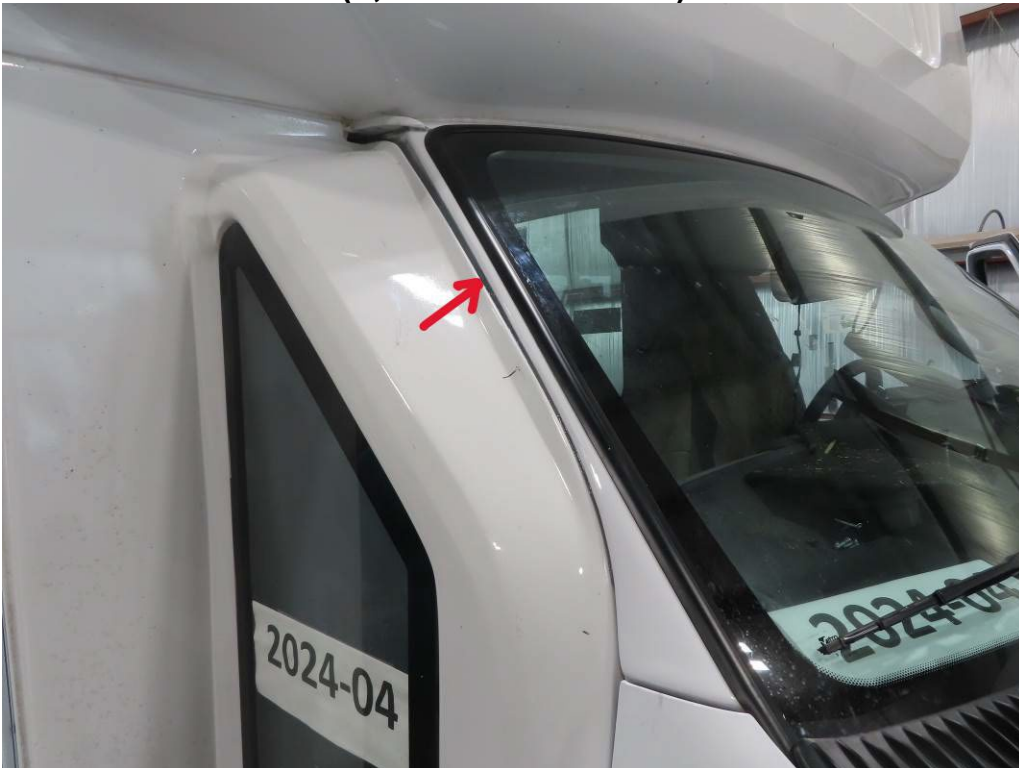
**CAULKING IS SEPARATING BETWEEN SUPPORT  
POST AND WINDSHIELD  
(4,975 TEST MILES)**
