# **FEDERAL TRANSIT BUS TEST**

**Manufacturer: High Level Enterprises, Inc.  
Model: 16 + 2WC**

**November 2024**

**Report Number: LTI-BT-R2024-04**

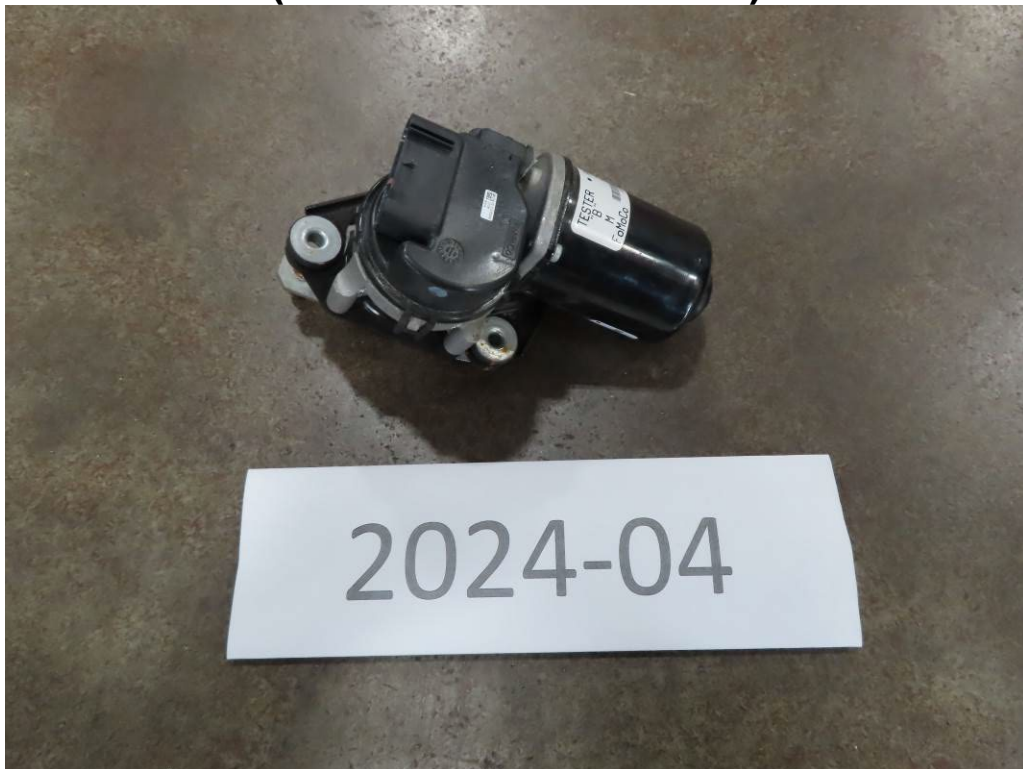
**WIPER MOTOR REMOVAL AND REPLACEMENT  
(0.17 LABOR HOURS)**

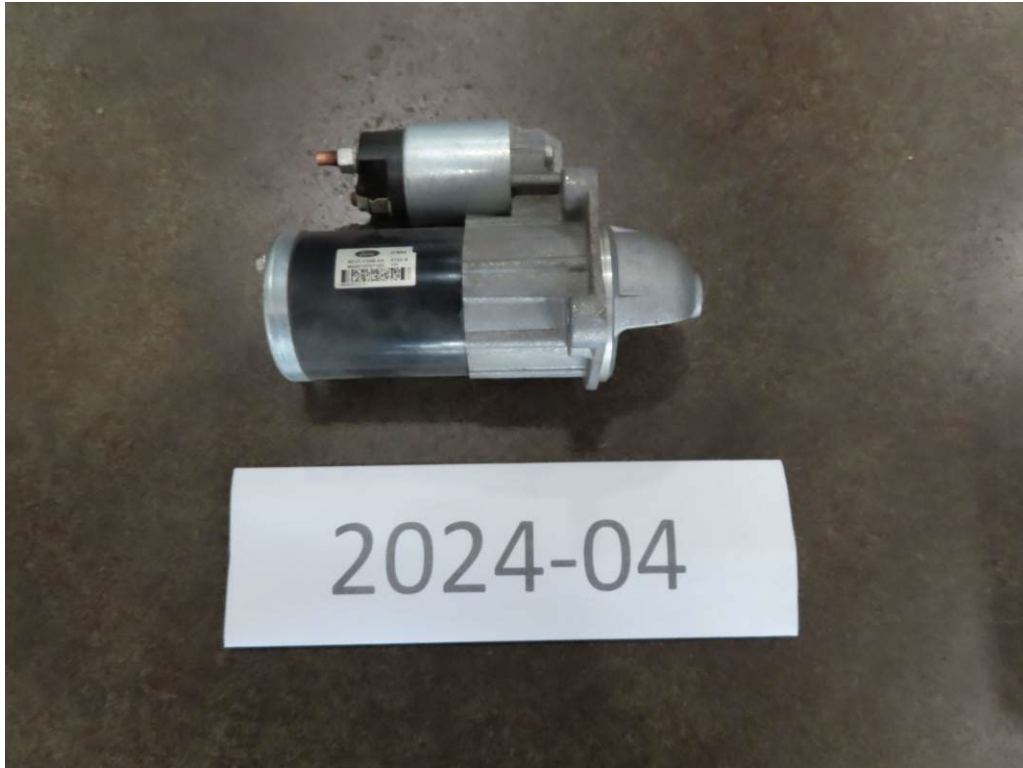
**STARTER REMOVAL AND REPLACEMENT  
(0.33 LABOR HOURS)**

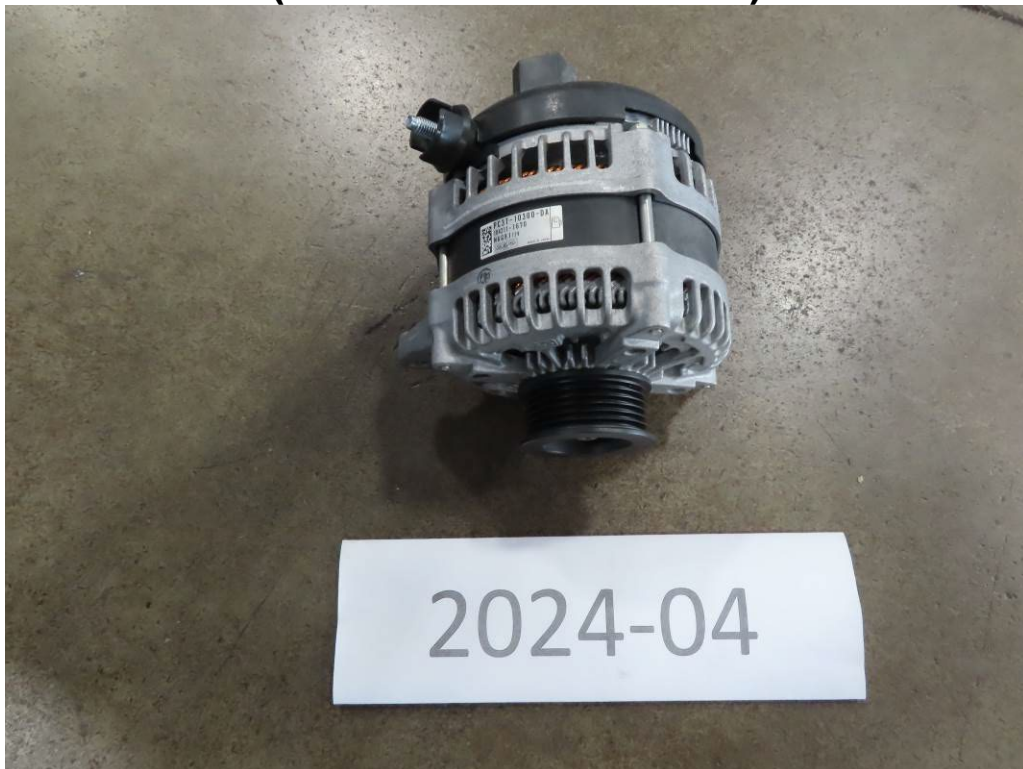
**ALTERNATOR REMOVAL AND REPLACEMENT  
(0.50 LABOR HOURS)**

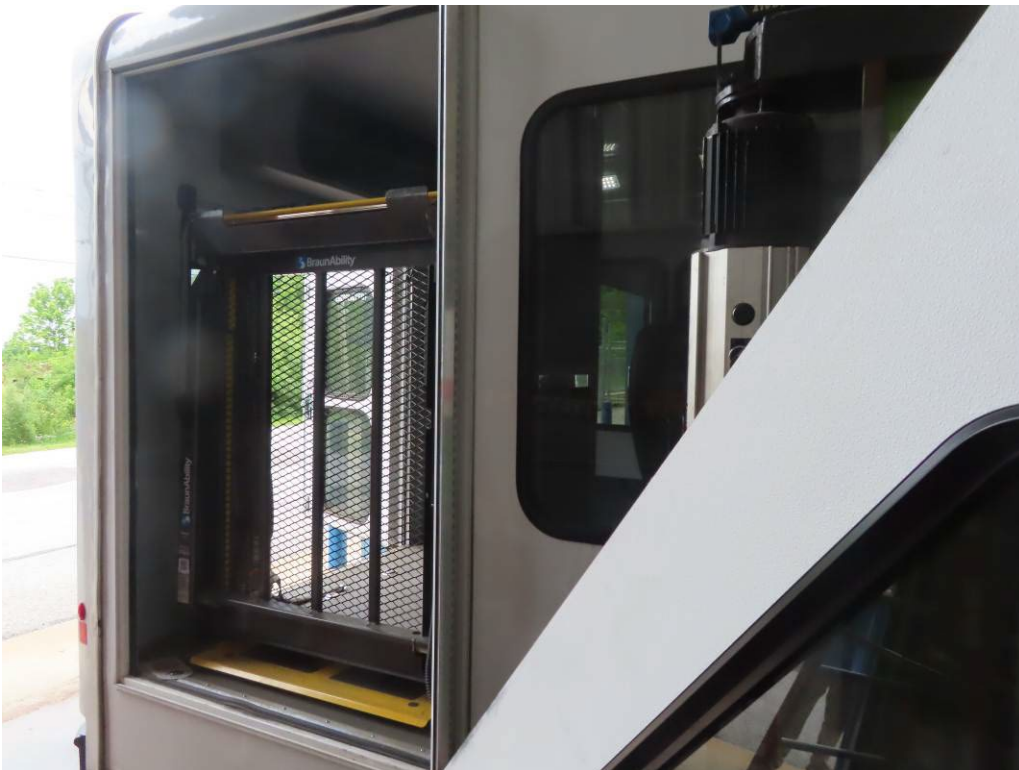
**ADA DOOR FELL OFF  
(4,579 TEST MILES)**

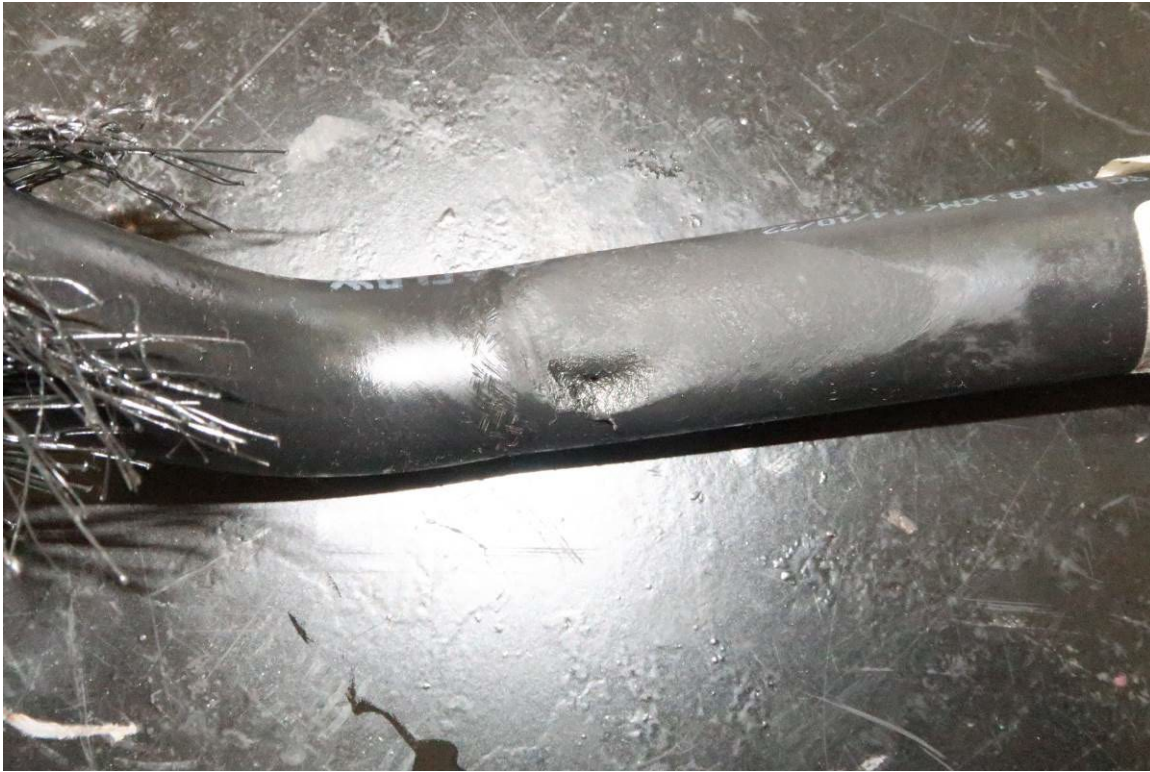
**HOLE ON INTAKE HOSE OF POWER STEERING PUMP  
(6,118 TEST MILES)**

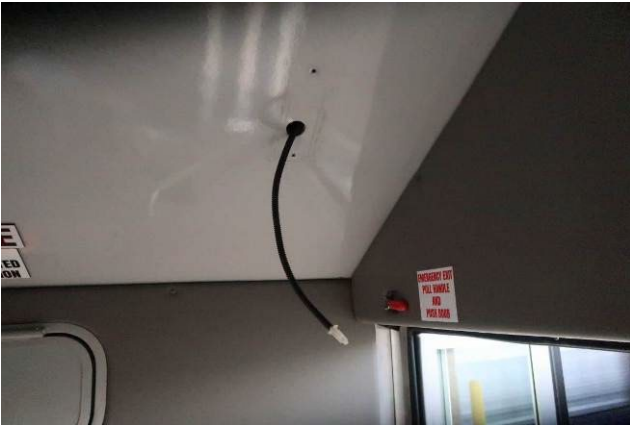
**INTERIOR LIGHT OVER PASSENGER DOOR FELL DOWN  
(7,486 TEST MILES)**
